## 2019-03-08 WTP 400 HYDRAULIC OIL SPILL

GN reference #: 2019-097

Please find the following information as a follow up to the spill report submitted March 8<sup>th</sup>, 2019 by Agnico Eagle. This detailed report is submitted to the Inspector in compliance with the conditions under the Nunavut Water Board License NWB-2AM-WTP1826, Part H, Item 8c.

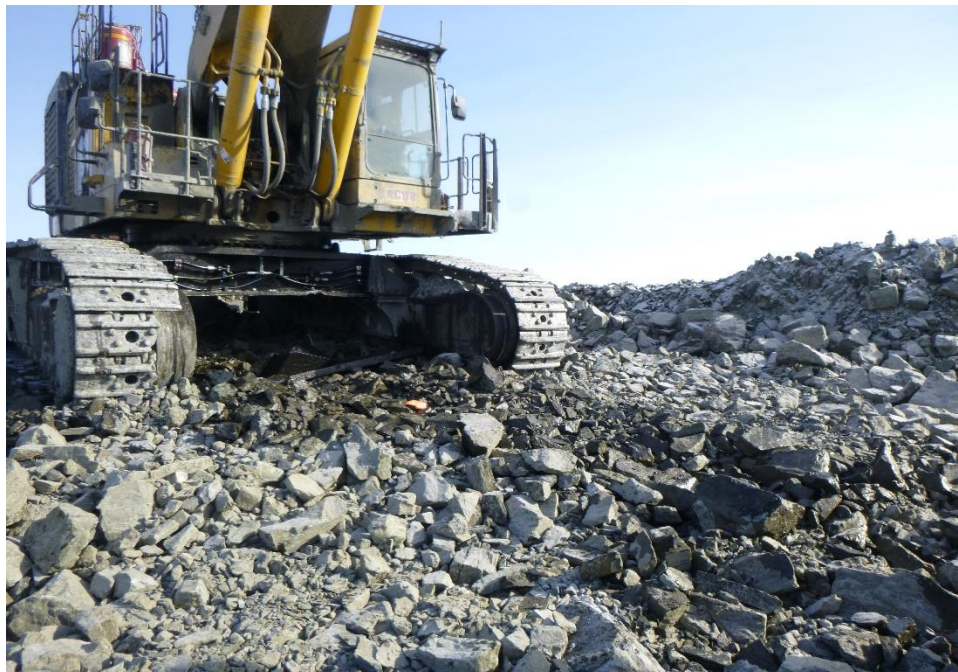
During operations at Whale Tail pit, a fitting on the main hydraulic line of backhoe failed, causing hydraulic oil to spill on the ground.

Location coordinates of the spill: Northing 65°24'11" Easting 96°42'27" on IOL.

There were no off site impact or discharge to any receiving watercourses. Distance to the closest lake is estimated at 150 meters outside of Quarry 2.

Failed fitting on the main hydraulic line on backhoe.
