2019-03-23 WTP 150 HYDRAULIC OIL SPILL

GN reference #: 2019-129

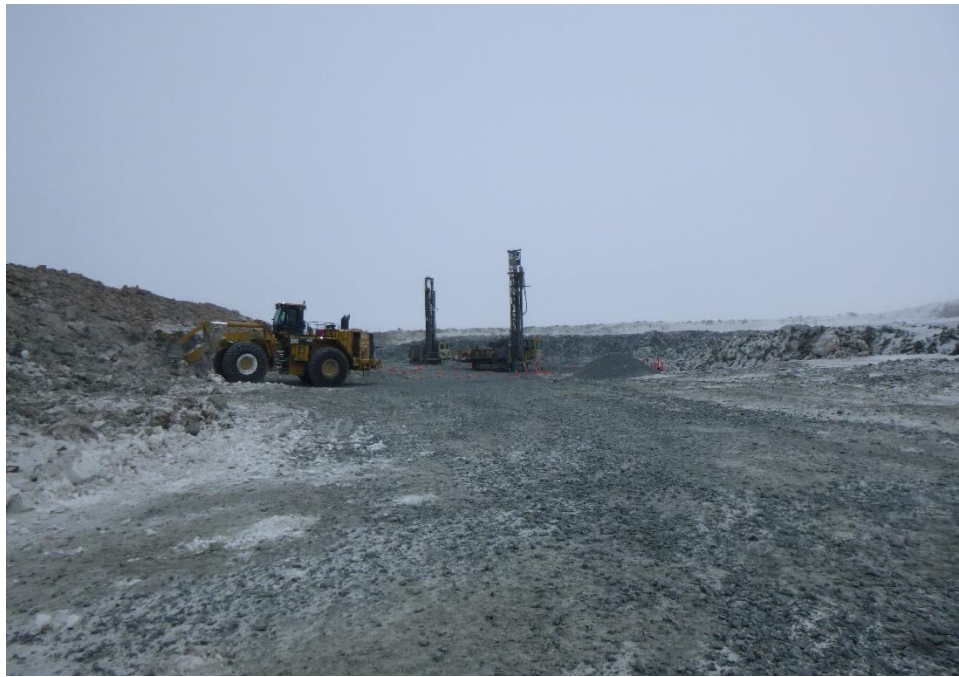
While on stand by at Whale Tail pit, the drill head crept down and the percussion of the hammer damaged the hydraulic oil hose, causing hydraulic oil to spill on the ground.

When the drill head crept down, the percussion of the hammer damaged the hydraulic oil hose.

The operator immediately stopped the equipment and called the maintenance department to fix the problem. All contaminated soil has been removed and has been brought to the landfarm at Meadowbank.

The hydraulic system including hoses and fittings are inspected as part of the preventive maintenance program done on site. Routine visual inspection of the hydraulic system is also performed during pre-operations checks.
