2019-04-20 WTP Quarry 2 400 liters Hydraulic Oil

GN reference #: 2019-164

Please find the following information as a follow up to the spill report submitted April 20, 2019 by Agnico Eagle. This detailed report is submitted to the Inspector in compliance with the conditions under the Nunavut Water Board License NWB-2AM-WTP1826, Part H, Item 8c.

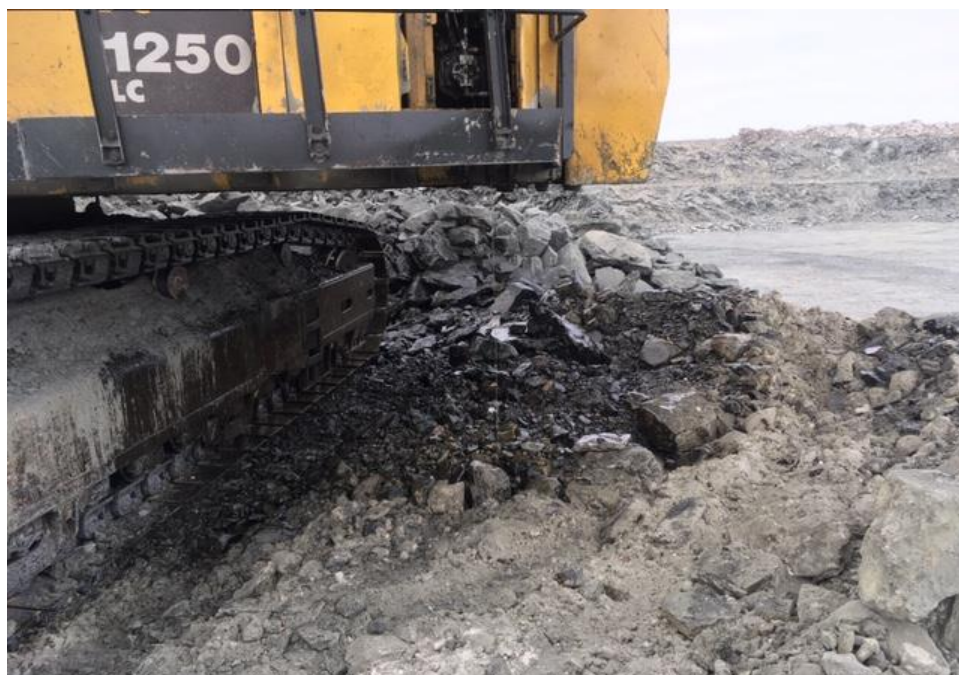
During operations at Whale Tail pit project, the hydraulic line to the pump of a 1250 backhoe failed causing hydraulic oil to spill on the ground.

There were no off site impact or discharge to any receiving watercourses. Distance to the closest lake is estimated at 150 meters outside Quarry 2.

Main hydraulic line of 1250 backhoe failed.

The operator immediately stopped the equipment and spill pads were placed on the area where the spill occurred. All contaminated material has been removed and has been brought to the landfarm at Meadowbank.

The hoses and fittings are inspected as part of the preventive maintenance program done on site. Routine visual inspection of the hydraulic lines is also performed during pre-operations checks.
