## 2019-06-16 WTP Quarry 2 450 Liters Hydraulic Oil

GN reference # : 2019-242

Please find the following information as a follow up to the Spill report submitted June 17<sup>th</sup>, 2019 by Agnico Eagle Meadowbank division. This detailed report is submitted to the Inspector in compliance with the conditions under the Nunavut Water Board License 2AM-WTP1826, Part H, Item 8c.

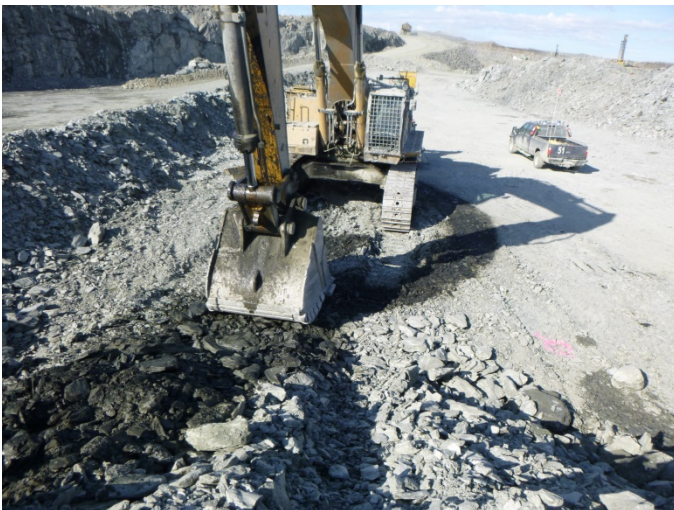
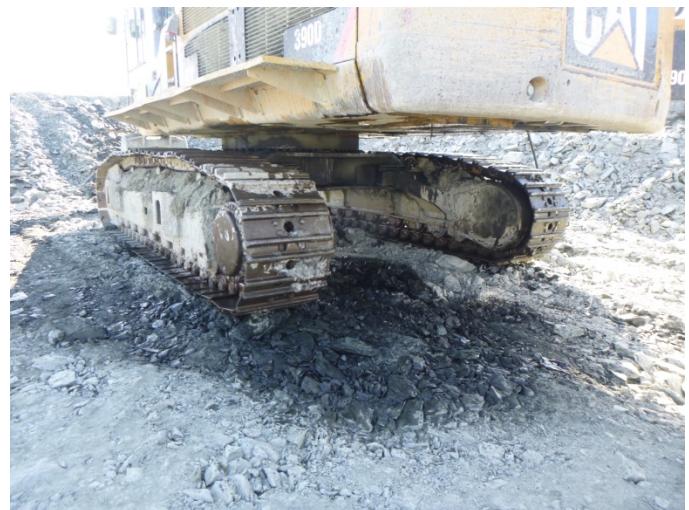
During operations the hydraulic system hose of BAC09 busted due to mechanical failure. The equipment was shut down and the contaminated material was picked up and brought to the landfarm at Meadowbank.

The spill has been caused by mechanical issue with the hose.

When he saw the oil during his move the operator stop the shovel and called for a mechanic. All the contaminated muck was sent to the tankfarm at Meadowbank.

A routine visual inspection of all system is performed during pre-operations checks as a part of the preventive maintenance program.
