2019-05-29 WTP TRK42 300 Liters Diesel

GN reference # : 2019-222

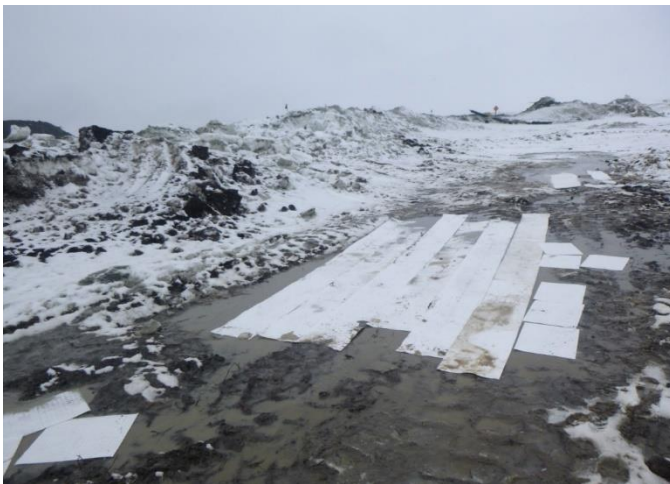
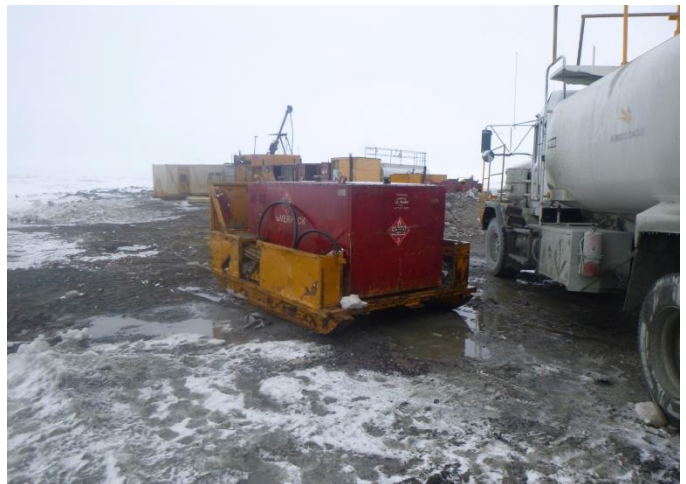
Spill location: N 65 24'30.8" W 096 40'54.8"

During operations the fuel truck was refilling the diamond drill over pack with diesel fuel. During pumping the worker left his work place to get material from his pick up truck. When he noticed the overflowing of diesel fuel, he immediately rushed back to the pump and stopped the pump.

The spill has been caused by human error when work left the pump during refueling.
