2019-04-06 WTP Quarry 2 300 Liters Hydraulic Oil

GN reference # : 2019-302

Please find the following information as a follow up to the Spill report submitted April 7, 2019 by Agnico Eagle Meadowbank division. This detailed report is submitted to the Inspector in compliance with the conditions under the Nunavut Water Board License 2AM-WTP1826, Part H, Item 8c.

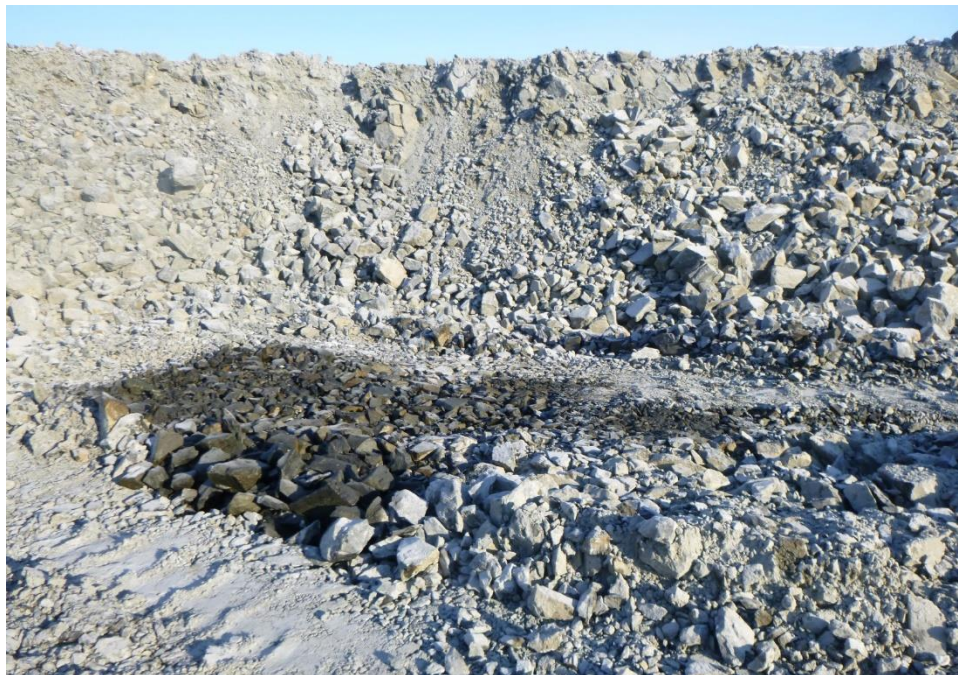
During operations, the flange bolt broke on the hydraulic hose of BAC13 causing hydraulic oil to spill on the ground.

The spill was caused due to a flange bolt failure on the main hydraulic hose.

A routine visual inspection of all systems, including hoses is performed during pre-operations checks as a part of the preventive maintenance program.

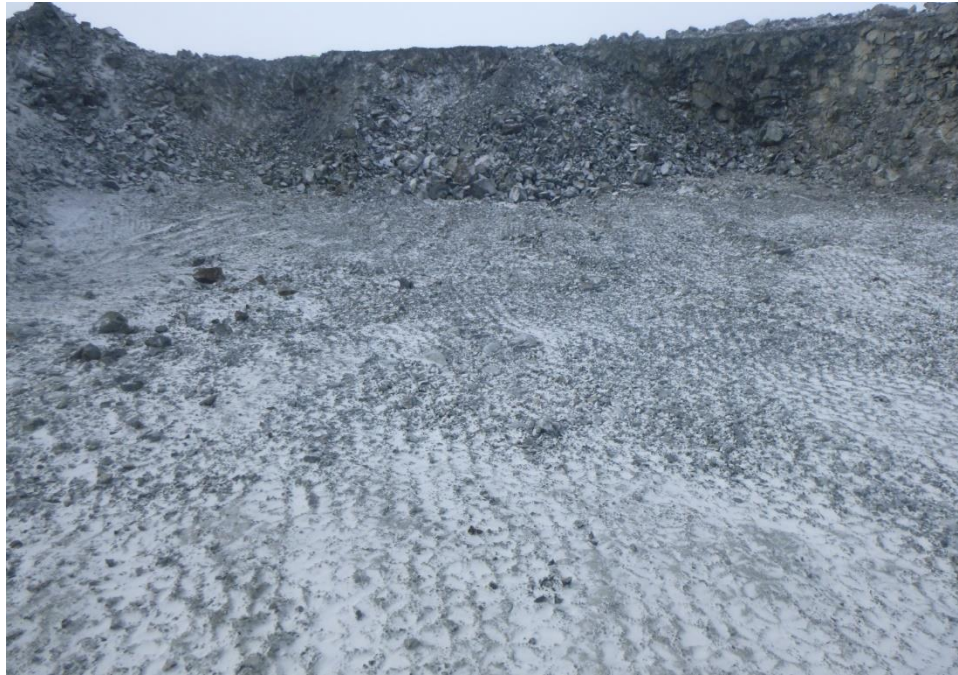
When the operator noticed the oil leak, he immediately stopped the equipment and called for a mechanic. All the contaminated material was removed and brought to the landfarm at Meadowbank.
