2019-08-09 WTP 200 Liters Hydraulic Oil

GN reference # : 2019-319

Please find the following information as a follow up to the Spill report submitted August 9, 2019 by Agnico Eagle Meadowbank division. This detailed report is submitted to the Inspector in compliance with the conditions under the Nunavut Water Board License 2AM-WTP1826, Part H, Item 8c.

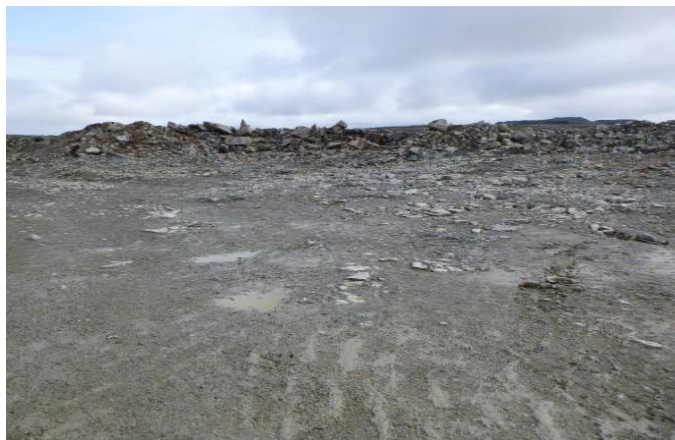
During operations at Whale Tail pit, the hydraulic hose underneath BAC13 broke due to mechanical failure causing hydraulic oil to spill on the ground.

The spill was due to the mechanical failure of the hydraulic hose.

The equipment was immediately shut down and maintenance was called to replace the broken hose. Once the hose was replaced and the equipment was moved, the contaminated material was removed and brought to the Meadowbank landfarm. Approximately 8m³ was brought to the landfarm.
