2019-08-31 WTP 120 Liters Hydraulic Oil

GN reference # : 2019-357

Spill Description

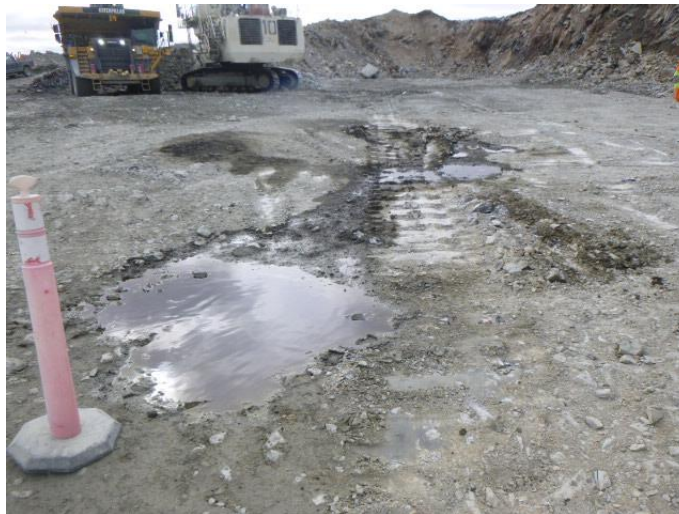
During operations at Whale Tail pit, the hydraulic hose at the rear of BAC13 broke due to mechanical failure causing hydraulic oil to spill on the ground.

The spill was due to the mechanical failure of the hydraulic hose.

The equipment was immediately shut down and maintenance was called to replace the broken hose. Once the hose was repaired and the equipment was moved, the contaminated material was removed and brought to the Meadowbank landfarm. Approximately 8m³ was brought to the landfarm.

A routine visual inspection of all systems and hoses is performed during pre-operations checks as a part of the preventive maintenance program.
