2019-01-01 AMQ 150 liters HYDRAULIC OIL

GN reference #: 2019-001

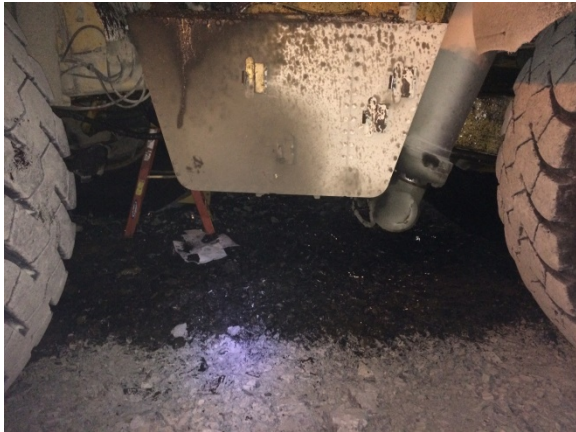
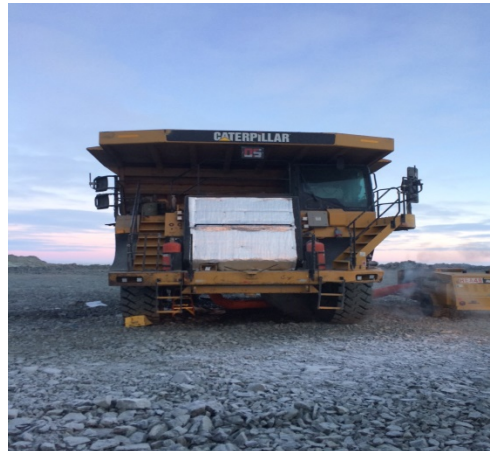
During operation at the Whale Tail Pit waste rock storage area, an hydraulic hose of the haul truck failed causing hydraulic oil to be spilled on the ground.

The leak was caused by a failure of an hydraulic hose.
