2019-07-08 WTP 100 Liters Diesel

GN reference # : 2019-273

Please find the following information as a follow up to the Spill report submitted July 9th, 2019 by Agnico Eagle Meadowbank division. This detailed report is submitted to the Inspector in compliance with the conditions under the Nunavut Water Board License 2BB-MEA1318, Part H, Item 5c.

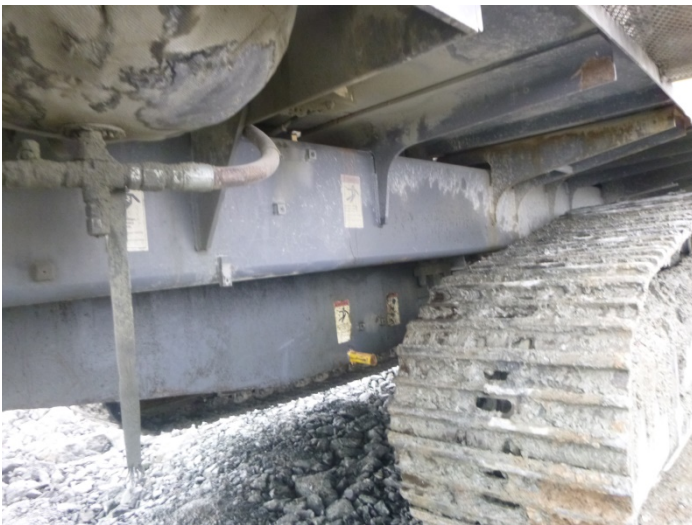
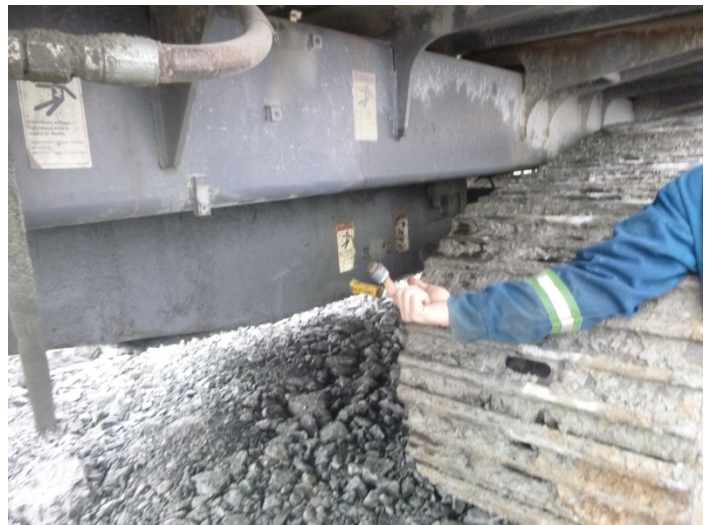
During operations at Quarry 2 of Whale Tail pit project, a rock on RBD04 drill got stuck between the track and fuel tank causing damage to the fuel tank drain plug.

The spill has been caused rock struck between the track and fuel tank causing damage to the fuel tank drain plug.

The drill was shut down and a secondary containment bucket was put underneath the fuel tank while the drain plug was replaced. The spill occurred on a blast pattern which was collected and processed through the Mill

A routine visual inspection of all system is performed during pre-operations checks as a part of the preventive maintenance program.
