## 2019-09-05 WTP Quarry 2 2500 Liters HYDRAULIC OIL

GN reference #: 2019-366

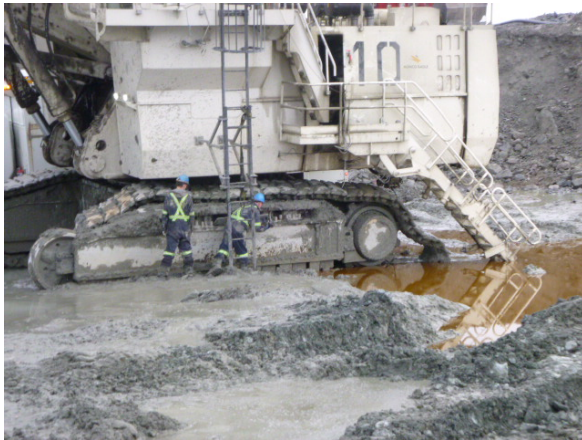
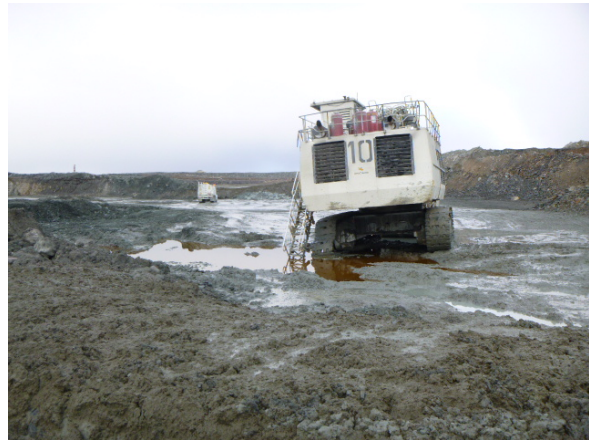
During operations at Whale Tail pit, the left track of BAC10 came off, damaging the tensioner cylinder which fully drained the oil tank of the backhoe. The equipment was shut down immediately.

The leak was caused after the BAC 10 left his track and damaging the tensioner cylinder which drained the oil tank.

The equipment was shut down and the hydraulic oil was pumped into totes. Once the oil has been pumped, the contaminated area has been excavated. The contaminated material was picked up and brought to the Meadowbank landfarm.

The hydraulic system including hoses and fittings are inspected as part of the preventive maintenance program done on site. Routine visual inspection of the hydraulic system is also performed during pre-operations checks.
