## 2019-09-10 WTP 240 Liters Coolant

GN reference # : 2019-372

Please find the following information as a follow up to the Spill report submitted September 11, 2019 by Agnico Eagle Meadowbank division. This detailed report is submitted to the Inspector in compliance with the conditions under the Nunavut Water Board License 2AM-WTP1826, Part H, Item 8c.

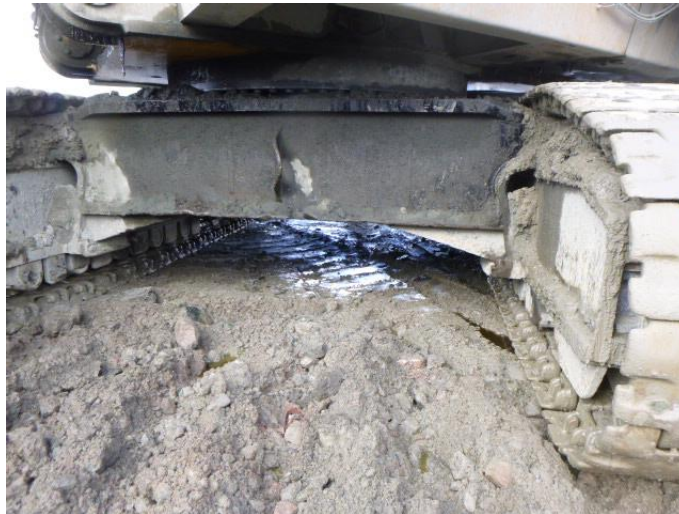
During operations at Whale Tail pit, the radiator hose of HTR21 let go, causing coolant to spill on the ground.

The spill was due to the mechanical failure of the radiator hose.

The equipment was immediately shut down and maintenance was called to replace the broken hose. Once the hose was repaired and the equipment was moved, the contaminated material was removed and brought to the Meadowbank south cell tailings.
