## 2019-10-20 MBK 120L TRANSMISSION FLUID SPILL

GN reference #: 2019-431

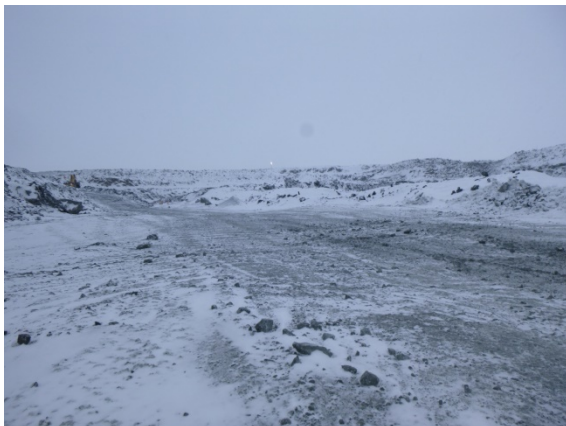
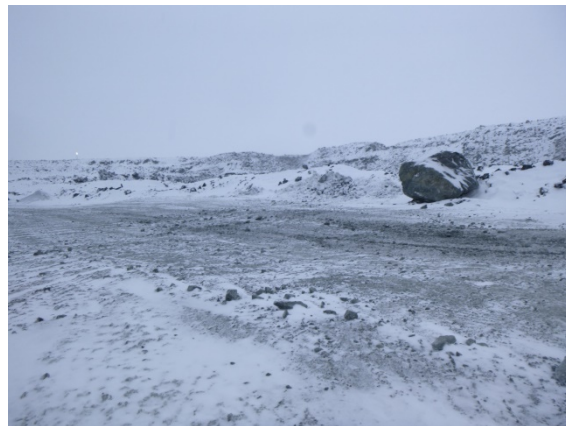
During operations at Whale Tail pit, the transmission filter came off emptying the tank.

Upon further inspection, it was observed that the filter had been cross threaded.

The equipment was shut down and the contaminated soil was collected and put in the yellow roll off bin to be brought to the Meadowbank landfarm. 8 m<sup>3</sup> of contaminated material was collected.

The hydraulic system including hoses and fittings are inspected as part of the preventive maintenance program done on site. Routine visual inspection of the hydraulic system is also performed during pre-operations checks.
