2019-10-24 WTP 200L FUEL SPILL

GN reference #: 2019-439

Please find the following information as a follow up to the spill report submitted October 24th, 2019 by Agnico Eagle. This detailed report is submitted to the Inspector in compliance with the conditions under the Nunavut Water Board License NWB-2AM-WTP1826, Part H, Item 8c.

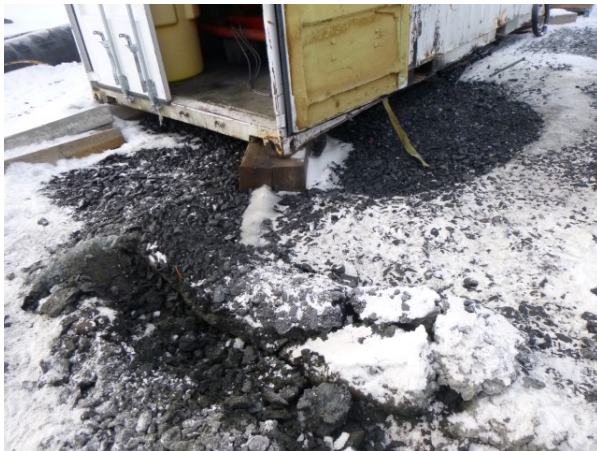
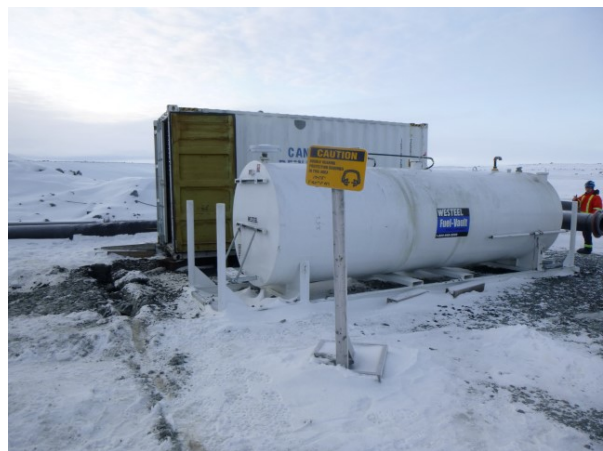
During dewatering operations at Whale Tail pit project, the fuel line on dewatering pump PWA02 let go creating the fuel return line to leak inside the pump sea can on the dewatering pad.

He spill was cause by a leak in the return line.

The fuel line was replaced and the sea-can will be moved to remove any contaminated material that leaked outside the seacan. All contaminated material will be picked up and brought to the landfarm in Meadowbank.
