2019-11-27 WTP 120L Hydraulic Oil

GN reference # : 2019-474

Please find the following information as a follow up to the Spill report submitted November 28th, 2019 by Agnico Eagle Meadowbank division. This detailed report is submitted to the Inspector in compliance with the conditions under the Nunavut Water Board License 2AM-WTP1826, Part H, Item 8c.

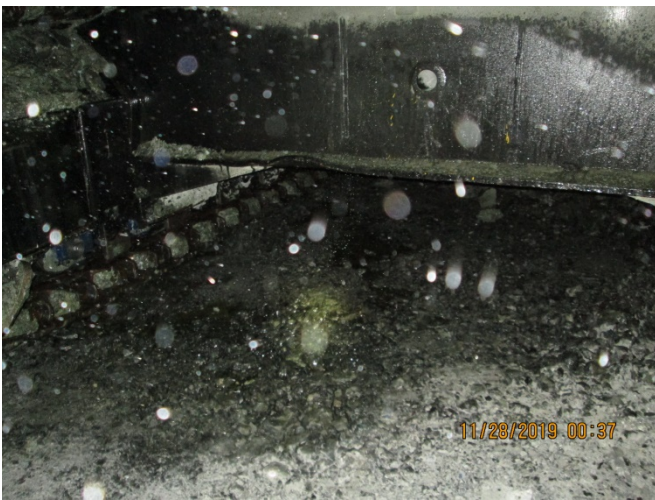
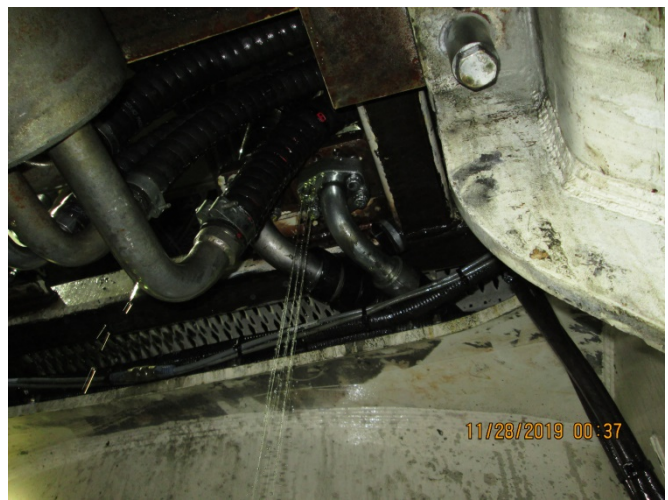
During operations at Whale Tail pit, one of the bolts holding a hydraulic line broke, causing hydraulic oil to spill to the ground.

The spill was due to the mechanical failure of the bolts holding hydraulic line.
