## 2019-12-14 WTP 125L Hydraulic Oil

GN reference # : 2019-483

Please find the following information as a follow up to the Spill report submitted December 14, 2019 by Agnico Eagle Meadowbank division. This detailed report is submitted to the Inspector in compliance with the conditions under the Nunavut Water Board License 2AM-WTP1826, Part H, Item 8c.

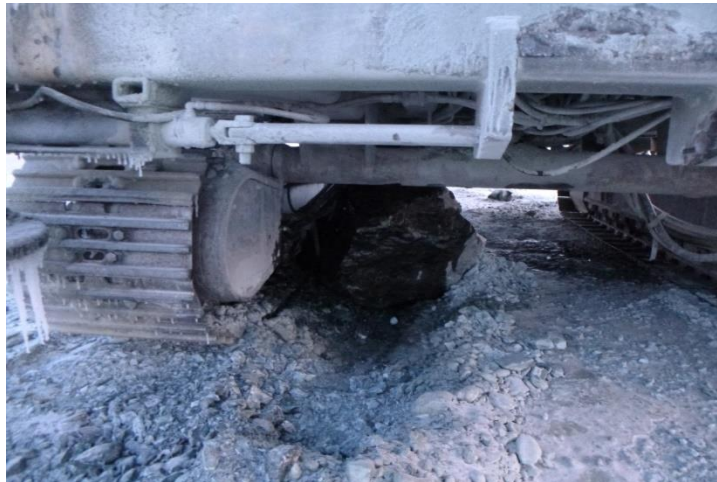
During operations at Whale Tail pit, an operator was moving drill RBD01 to the next pattern and made contact with a spill rock from a haul truck causing oil to spill from the tank.

The spill occurred when drill RBD01 made contact with a rock, damaging the hydraulic oil tank.

A reminder to all operators to call grader/loader to remove any spill rocks on haul roads.

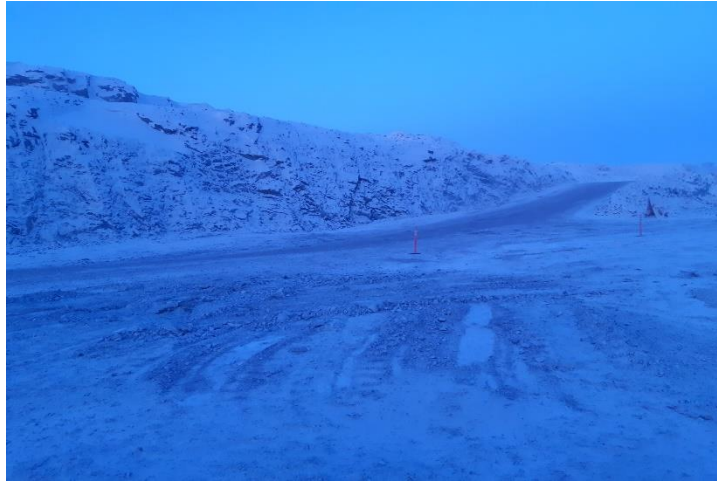
The equipment was shut down and maintenance was called. Once the repairs were made and the drill was moved, the contaminated material was picked up and brought to the Meadowbank landfarm. Approximately 2m3 of contaminated material was collected.
