2019-12-19 WTP 150L Hydraulic Oil

GN reference # : 2019-488

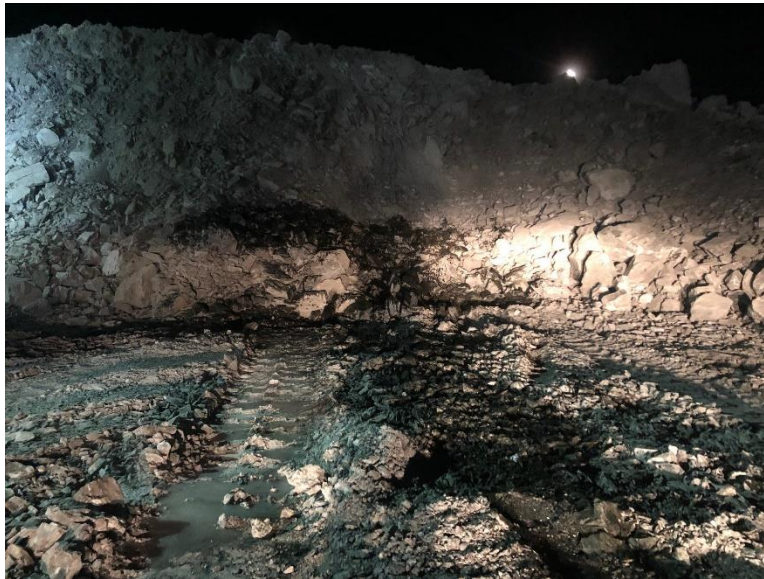
During operations at Whale Tail pit, the hydraulic hose for the clam of the bucket on BAC13 failed, causing hydraulic oil to spill on the ground.

Spill location: N 65 24'21.1'' W 096' 42'05.4'' on IOL

The spill occurred due to a hydraulic hose failure on the clam.
