2019-12-28 WTP 200 L Hydraulic Oil

GN reference #: 2019-493

Please find the following information as a follow up to the Spill report submitted December 28, 2019 by Agnico Eagle Meadowbank division. This detailed report is submitted to the Inspector in compliance with the conditions under the Nunavut Water Board License 2AM-WTP1826, Part H, Item 8c.

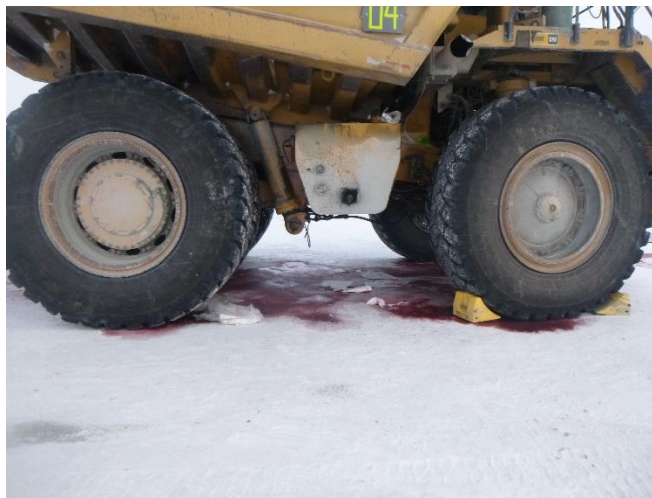
During operations at the Waste Rock Storage Facility, the hydraulic system the haul truck failed. The equipment was immediately shutdown to prevent further spillage.

The spill occurred due to a failure on the main hydraulic lines of the truck caused by cold temperatures.

A routine visual inspection of all systems and hoses is performed during pre-operational checks as a part of the preventative maintenance program.
