AGNICO EAGLE

Re.: Agnico Eagle Whale Tail Project – WRSF Flow Follow up (2019-333) - Additional Information

This letter provides additional information following the water flow through the Whale Tail Waste Rock Storage Facility (WRSF) Dike reported on August 25, 2019. Specifically, this letter includes:

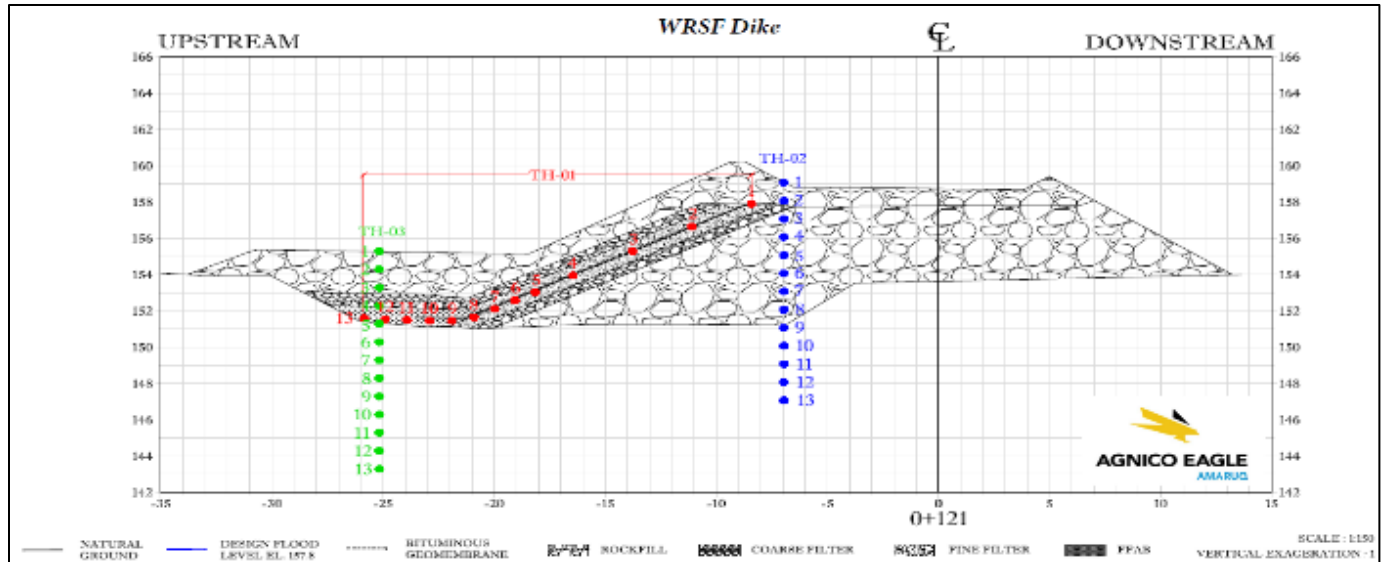
Figure 5: WRSF Thermistor TH1, TH2, TH3 locations (profile view)

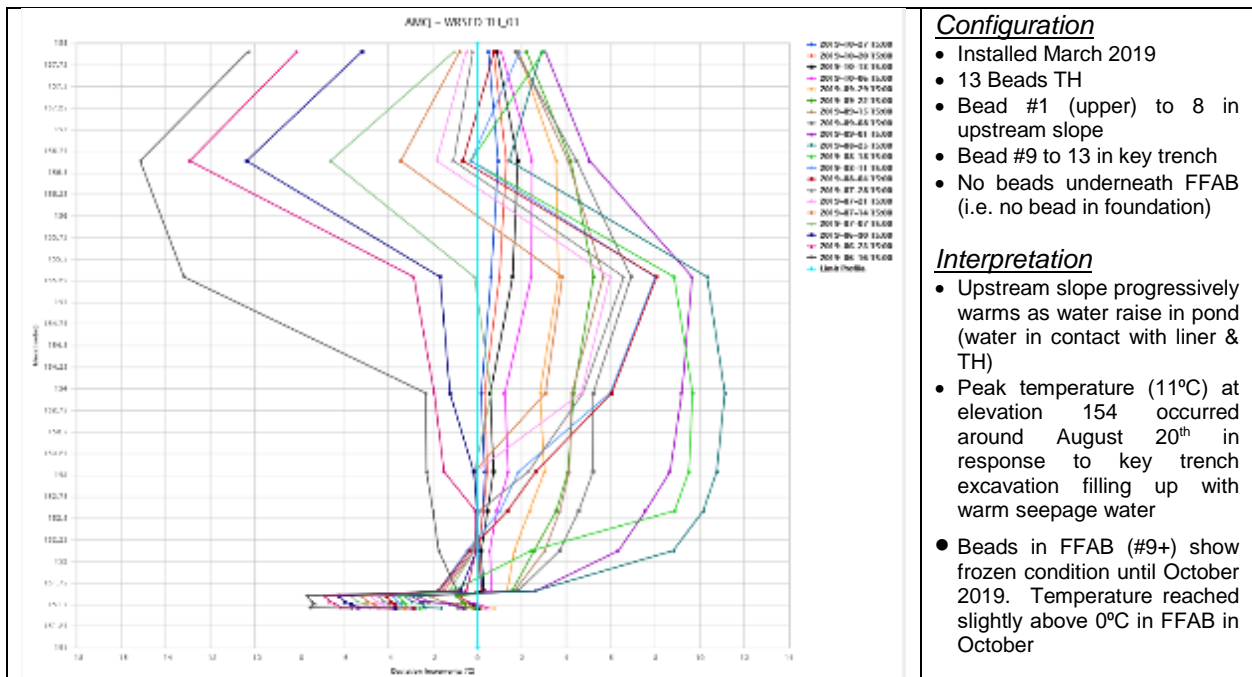
Figure 6: WRSF Temperature profile of thermistor TH-01

- Installed March 2019
- 13 Beads TH
- Bead #1 (upper) to 8 in upstream slope
- Bead #9 to 13 in key trench
- No beads underneath FFAB (i.e. no bead in foundation)

- Upstream slope progressively warms as water raise in pond (water in contact with liner & TH)
- Peak temperature (11°C) at elevation 154 occurred around August 20th in response to key trench excavation filling up with warm seepage water
- Beads in FFAB (#9+) show frozen condition until October 2019. Temperature reached slightly above 0°C in FFAB in October

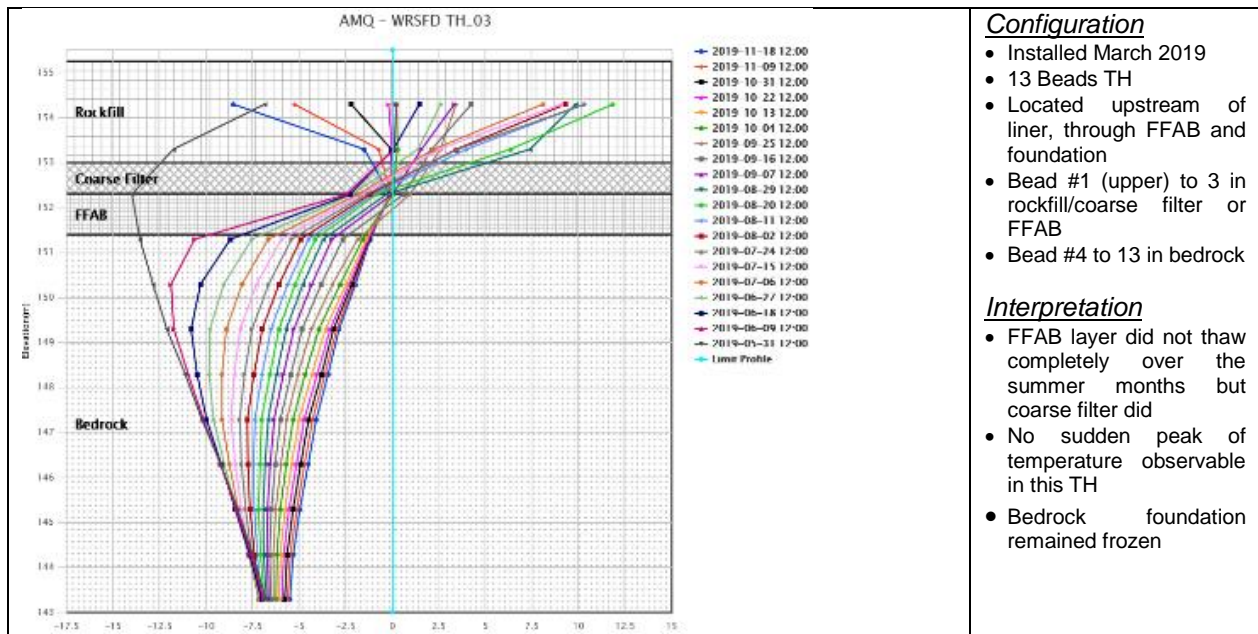
Figure 8: WRSF Temperature profile of thermistor TH-03

Thermal monitoring results suggest that thawing of the dike foundation occurred, resulting in an increase of its hydraulic conductivity that led to the seepage. Thawing of the foundation has probably been induced by the higher than anticipated accumulation of water in the pond coupled with an insufficient thermal protection on the upstream toe of the dike.

Over the summer, the pond experienced high water levels (still within design limits) resulting from higher than anticipated precipitation. These sustained high water levels led to warming/thawing of the key trench plug (FFAB, Fine Filter Amended with Bentonite) at approximately elevation 152.5 m as shown in Figure 8 (TH-03). Thawing of the key trench created a sudden pathway for water to migrate downstream.

- The water level in the WRSF pond will be maintained at a low level throughout 2020 as per recommendation from the MDRB as a precautionary measure and to ensure protection of the freeze-back of the key trench;
- Permafrost penetration will be promoted during winter 2019-2020 by implementing a series of additional measures to increase the robustness of the infrastructure and in particular the upstream toe against permafrost degradation:
 - Strategic snow removal to keep the toe more exposed to winter conditions;
 - Keeping a low water level (if any) in the pond during winter and summer months;
 - Placing additional thermal cover material on the upstream portion of the dike; and
 - Assessing freeze back performance with periodic instrumentation review;
- A more robust downstream water collection system will be designed and constructed; and
- Thermistors monitoring will continue.
