2020-01-20 WTP 150 L Engine Oil Tote

GN reference #: 2020-019

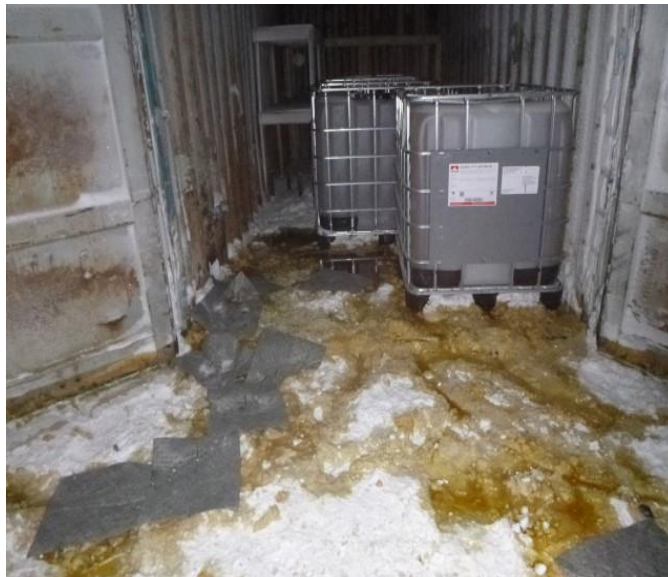
During operations at the Whale Tail pit, a worker was moving totes in and out of a sea can. The operator was unaware he punctured a tote. During night shift, another worker went to get a tote from the sea can and discovered the spill.

The spill occurred due to a punctured tote from the loader forks.

All equipment operators using forks to move material will use a spotter to prevent incident/material damage .

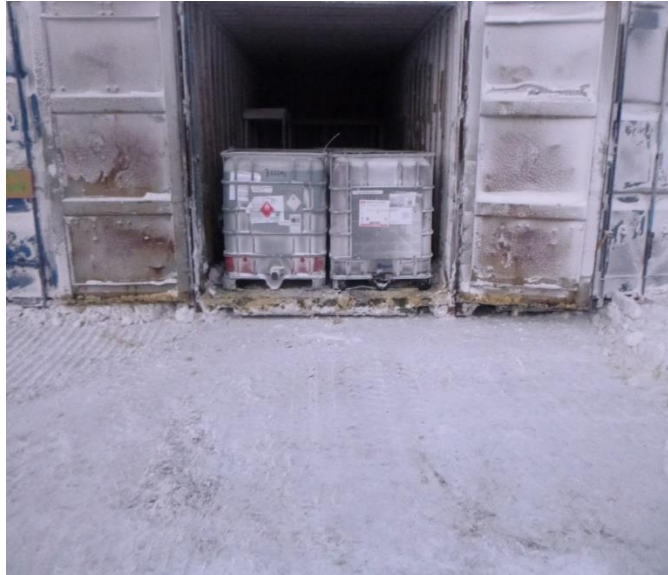
Spill pads were placed on the ground outside the sea can and the totes were removed. The sea can was cleaned out and all the spill pads were sent to the Hazmat storage area. Approximately 2m3 of contaminated snow and material was collected and brought to the land farm at Meadowbank.
