2020-05-17 WTP 250L Engine Oil

GN reference #: 2020-140

Spill Description

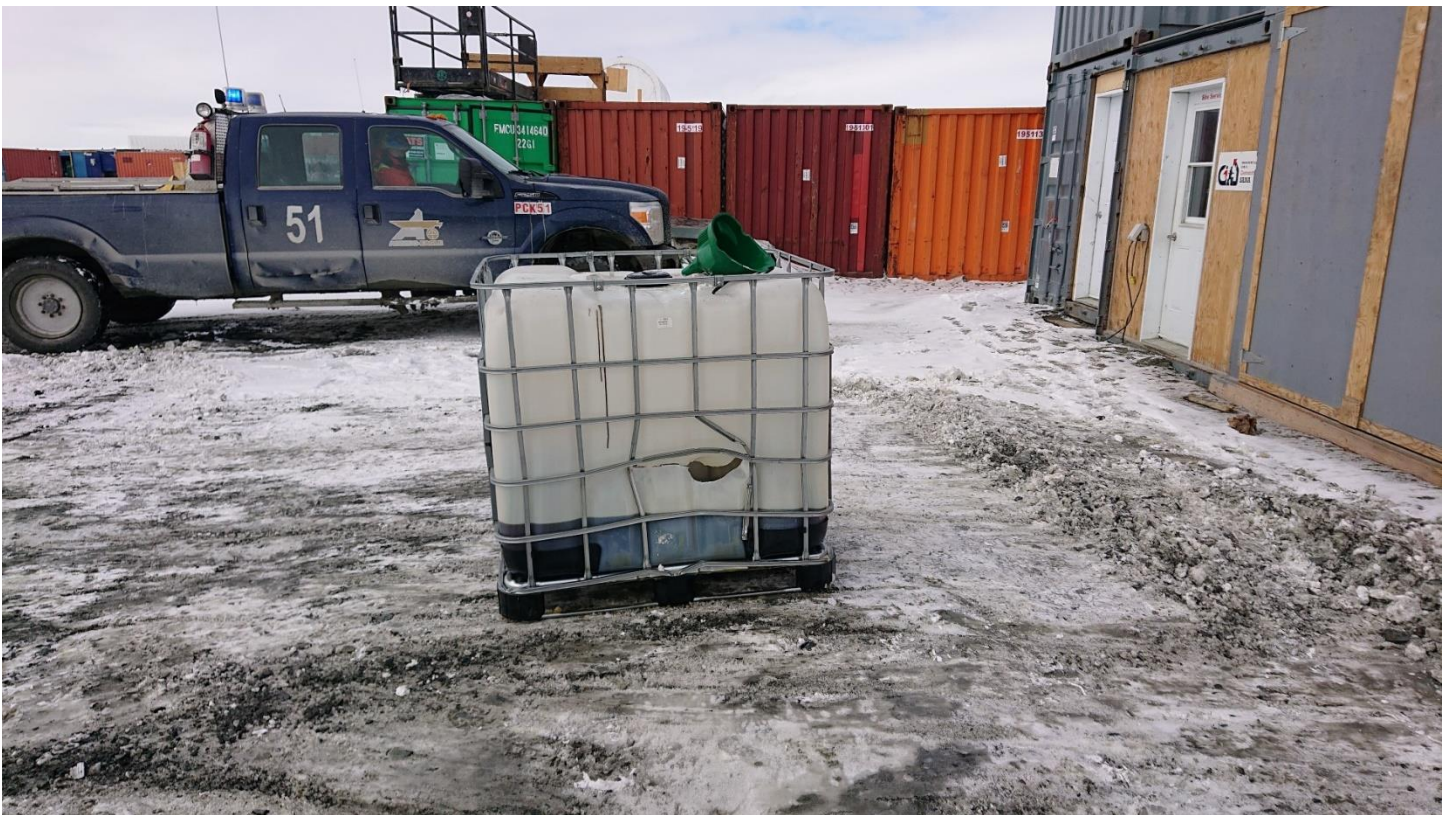
During operations at the Whale Tail pit, an operator was attempting to move an engine oil tote on the ground. The operators swivel forks jumped and punctured the side of the tote.

Spill location: 65° 23'58.4" 96° 40'39.9" on IOL

The spill occurred due to human error by the loader operator.

Spill pads were placed on the ground and approximately 4m³ of contaminated snow and material was collected and brought to the land farm at Meadowbank.

A routine visual inspection of all system is performed during pre-operations checks as a part of the preventative maintenance program. Operators were reminded to ensure that all parts of the equipment are to be inspected and conform to operational standards.
