## 2020-05-29 WTP 200L Diesel

GN reference #: 2020-152

Please find the following information as a follow up to the Spill report submitted May 29, 2020 by Agnico Eagle Meadowbank division. This detailed report is submitted to the Inspector in compliance with the conditions under the Nunavut Water Board License 2AM-WTP1830, Part H, Item 8c.

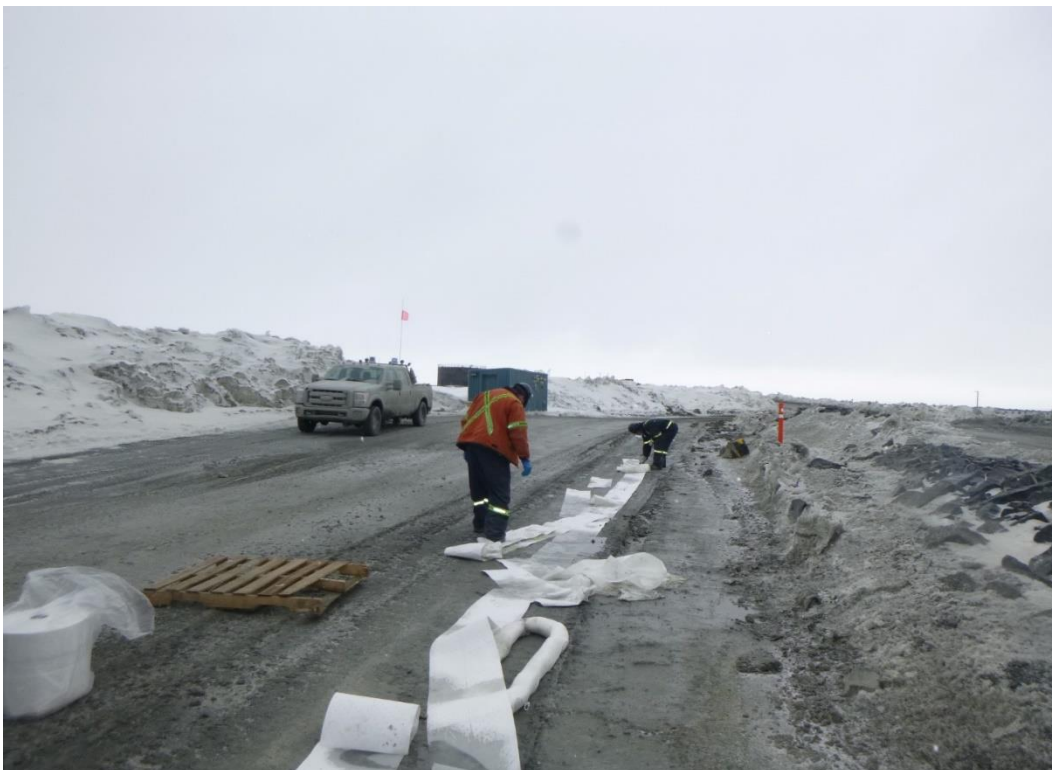
During operations at Whale Tail pit, the operator of long-haul truck LHT16 stopped at the wheel torque area to check his tires, when the operator noticed a diesel leak spilling onto the ground.

The spill occurred due to frozen build up of mud between the tires and the fuel tank. The vibration from the long-haul truck caused that build up of mud to put pressure on the fuel tank, causing a small puncture/crack on the tank.

A routine visual inspection of all systems is performed during pre-operations checks as a part of the preventative maintenance program. LHT operators will check for mud build up during routine inspections/tire checks along the WTHR.
