2020-08-07 WTP Runoff TSS

Please find the following information as a follow up to the Spill report submitted August 7th, 2020 by Agnico Eagle Meadowbank division. This detailed report is submitted to the Inspector in compliance with the conditions under the Nunavut Water Board License 2AM-WTP1830, Part H, Item 8c.

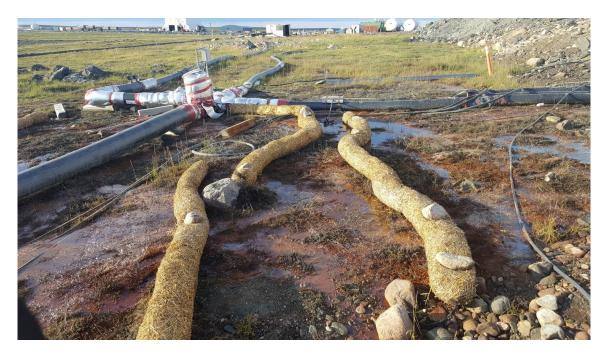
During a regular Whale Tail site inspection by the environment department, turbid water was observed to be running off from one of the pads. The water was sampled, and found to have total suspended solids of 345 mg/L.

The source of water is expected to be natural runoff, while the suspended solids are expected to be caused by microbial process.

Straw booms were placed to contain the water, until a sump was excavated to pump the water into GSP1. Daily internal water samples were collected, and weekly samples were sent for analysis. Investigation as to what the source of the water ingress could have been. All surrounding pipes were air-tested for leaks, and dye-tracing tests were performed in the nearest building. All test concluded no leaks were present.
