2020-07-07 WTP 200L Diesel

Please find the following information as a follow up to the Spill report submitted July 8, 2020 by Agnico Eagle Meadowbank division. This detailed report is submitted to the Inspector in compliance with the conditions under the Nunavut Water Board License 2AM-WTP1830, Part H, Item 8c.

Spill Description

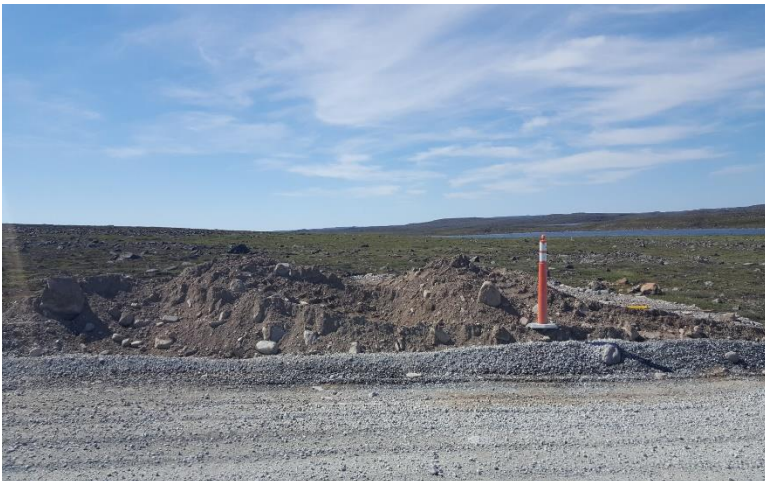
During operations on the Whale Tail Haul Road, the drive shaft of long haul truck 15 (LHT15) sustained a mechanical equipment failure, causing damage to the passenger side fuel reservoir and spilling fuel on the Whale Tail Haul road.

The spill occurred due to damage on the passenger side fuel reservoir on long haul truck LHT15.

The LHT was moved to a pull off area along the road. Spill pads and secondary containment were placed under the fuel tank. Approximately 5m³ of contaminated material was collected and brought to the MBK landfarm.

A routine visual inspection of all systems is performed during pre-operations checks as a part of the preventative maintenance program.
