## 2020-10-08 MBK 250L Diesel

GN reference #: 2020-389

Please find the following information as a follow up to the Spill report submitted October 9, 2020 by Agnico Eagle Meadowbank division. This detailed report is submitted to the Inspector in compliance with the conditions under the Nunavut Water Board License 2AM-MEA1530, Part H, Item 8c.

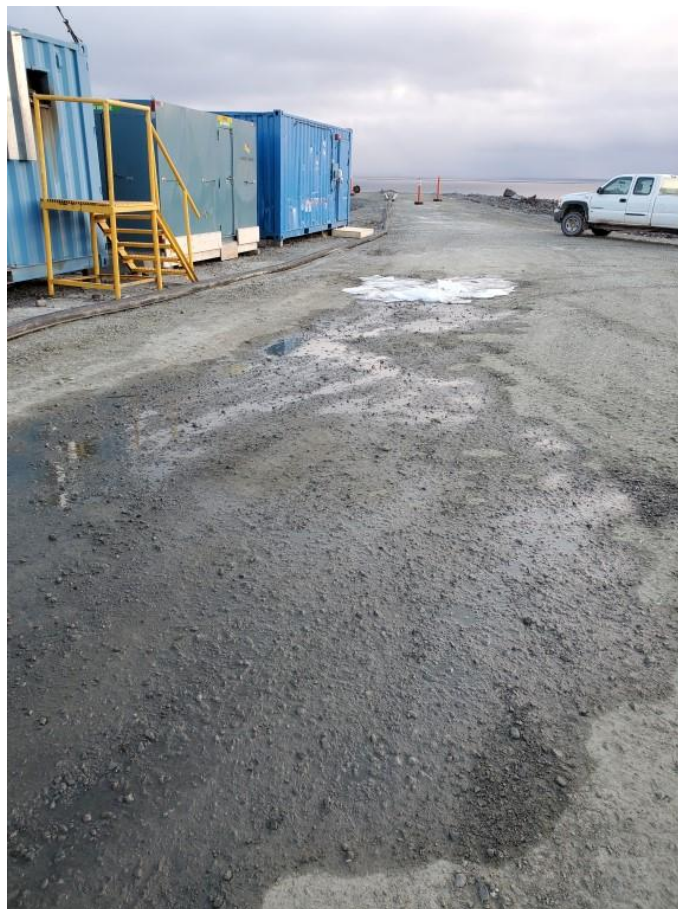
Spill location: 64° 18'26.85" 95° 56'57.86"

During operations at Meadowbank, a tanker was refueling at Baker Lake. The tanker was filled up faster than anticipated, causing excess fuel to spill onto the ground. A worker nearby used the emergency shutoff to minimize the spill. Absorbent pads were used to contain the spill, which covered roughly 15m<sup>2</sup>. Roughly 5m<sup>3</sup> of contaminated ground was immediately collected and disposed of in the contaminated soil bin.

The spill was caused by human error; failure to stop refueling when tank was full.
