## 2021-01-08 WTP 375L Coolant

GN reference #: 2021-008

Please find the following information as a follow up to the Spill report submitted January 9, 2021 by Agnico Eagle Meadowbank division. This detailed report is submitted to the Inspector in compliance with the conditions under the Nunavut Water Board License 2AM-WTP1830, Part H, Item 8c.

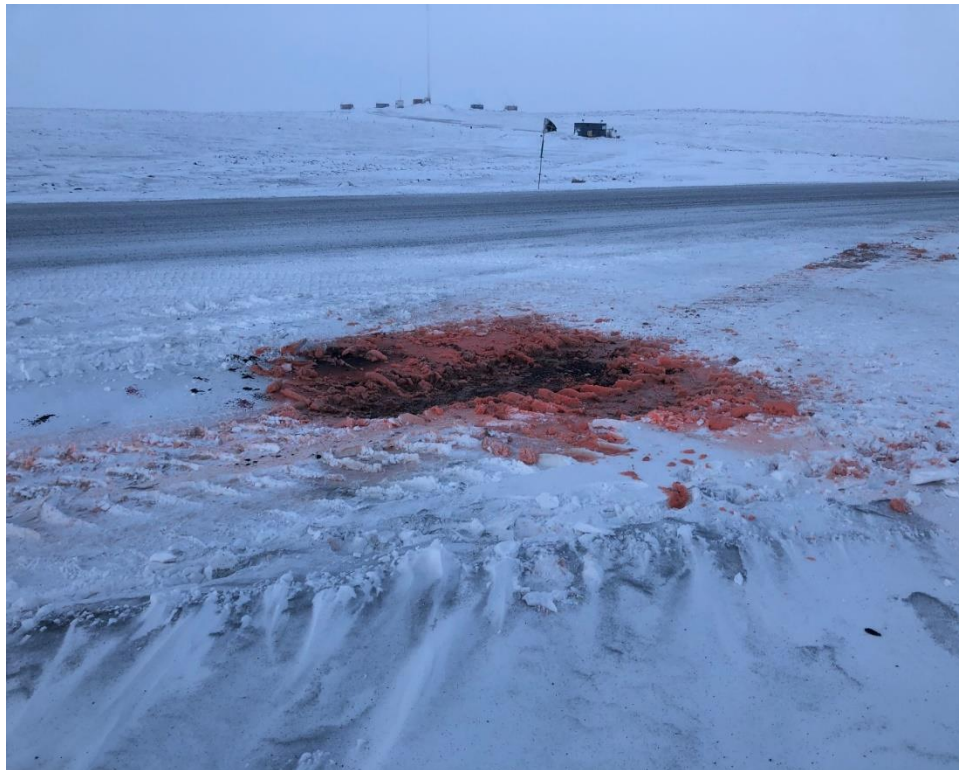
During operations, a radiator hose failure occurred on a haul truck while travelling on the Whale Tail Haul road, spilling coolant on the road.

Radiator Hose failure on Haul Truck 21.
