## 2021-04-18 WTHR 20L Diesel

GN reference #: 2021-128

Please find the following information as a follow up to the Spill report submitted April 18, 2021 by Agnico Eagle Meadowbank division. This detailed report is submitted to the Inspector in compliance with the conditions under the Nunavut Water Board License 2AM-WTP1830, Part H, Item 8c.

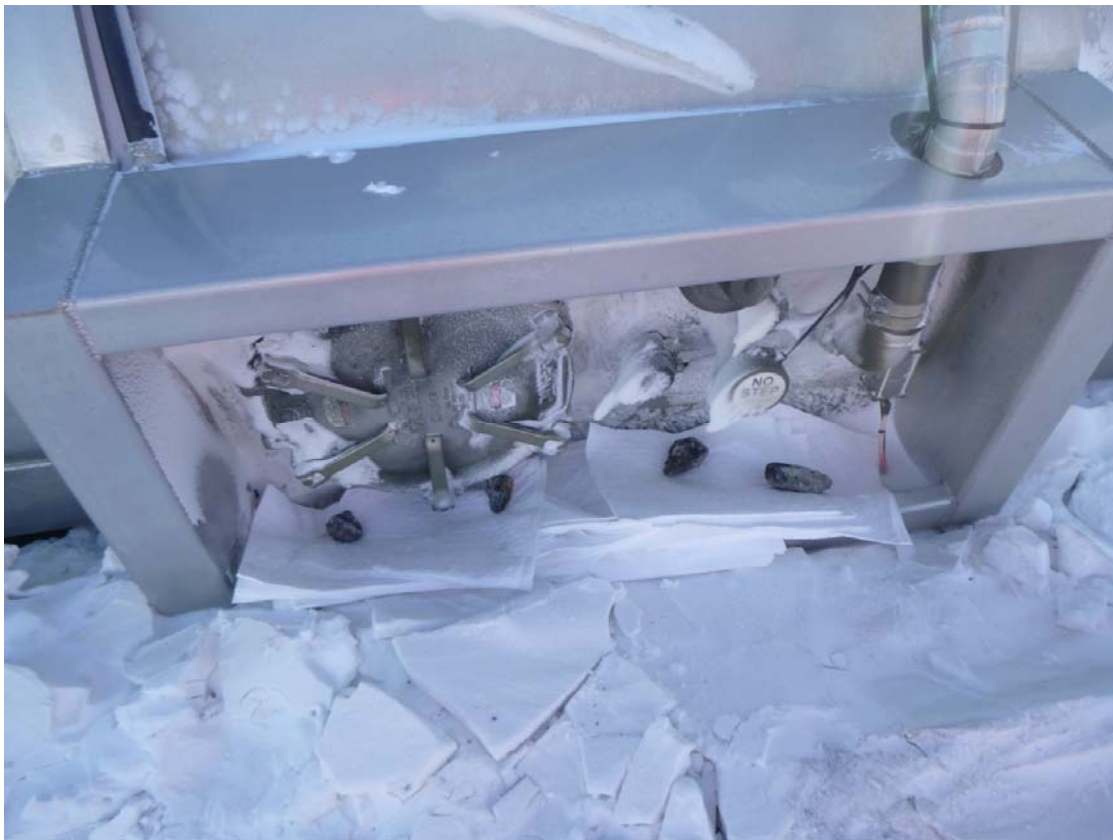
During operations at the Whale tail Pit, a loaded fuel tanker loss sight of the Whale Tail Haul Road due to poor visibility, and ended up on its side. A small slow fuel leak was observed from the top valve. It is estimated roughly 20L of diesel fuel was spilled into the snow, covering less than 1m<sup>2</sup>.

Spill location: 65°24'0.9" 96°37'14" on IOL.

There were no off site impacts or discharge to any receiving watercourses. Distance to the closest water body is 300 meters to an unnamed lake along the Whale Tail Haul Road.

Equipment tipped over due to low visibility.

A safety standdown was done by the fuel operators to review procedures and to ensure equipment are parked if visibility is reduced. Agnico Eagle has a strict safety protocol in place concerning road status when low visibility is present.
