## 2021-05-27 WTP 150L Diesel

GN reference #: 2021-212

Please find the following information as a follow up to the Spill report submitted May 27, 2021 by Agnico Eagle Meadowbank division. This detailed report is submitted to the Inspector in compliance with the conditions under the Nunavut Water Board License 2AM-WTP1830, Part H, Item 8c.

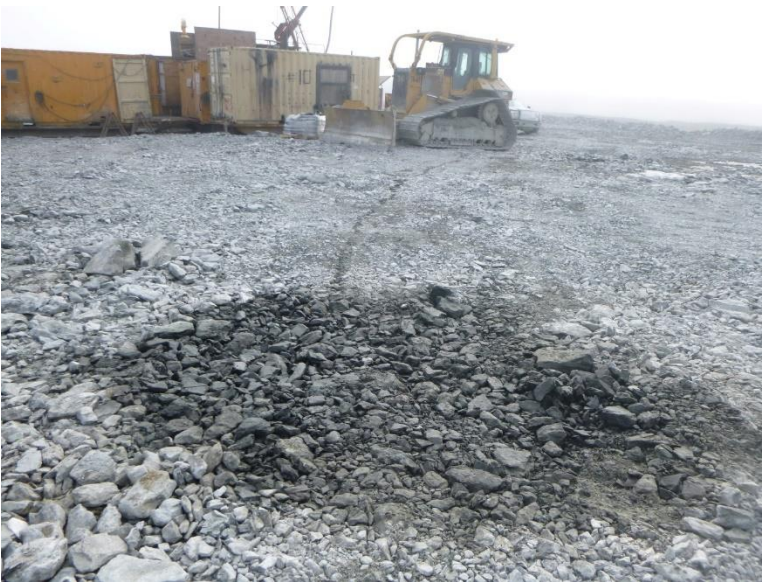
During an Environmental inspection at the Whale Tail Pit project, a diesel fuel spill was found on the ground at the drill storage pad. An overfill during refueling on night shift is the most probable cause of this occurrence.

Spill location: 65 24'47.49" 96 41'49.71" on IOL.

Unknown but most likely due to an overfill during refilling.
