## 2021-07-11 WTP 400L Hydraulic Oil

GN reference #: 2021-296

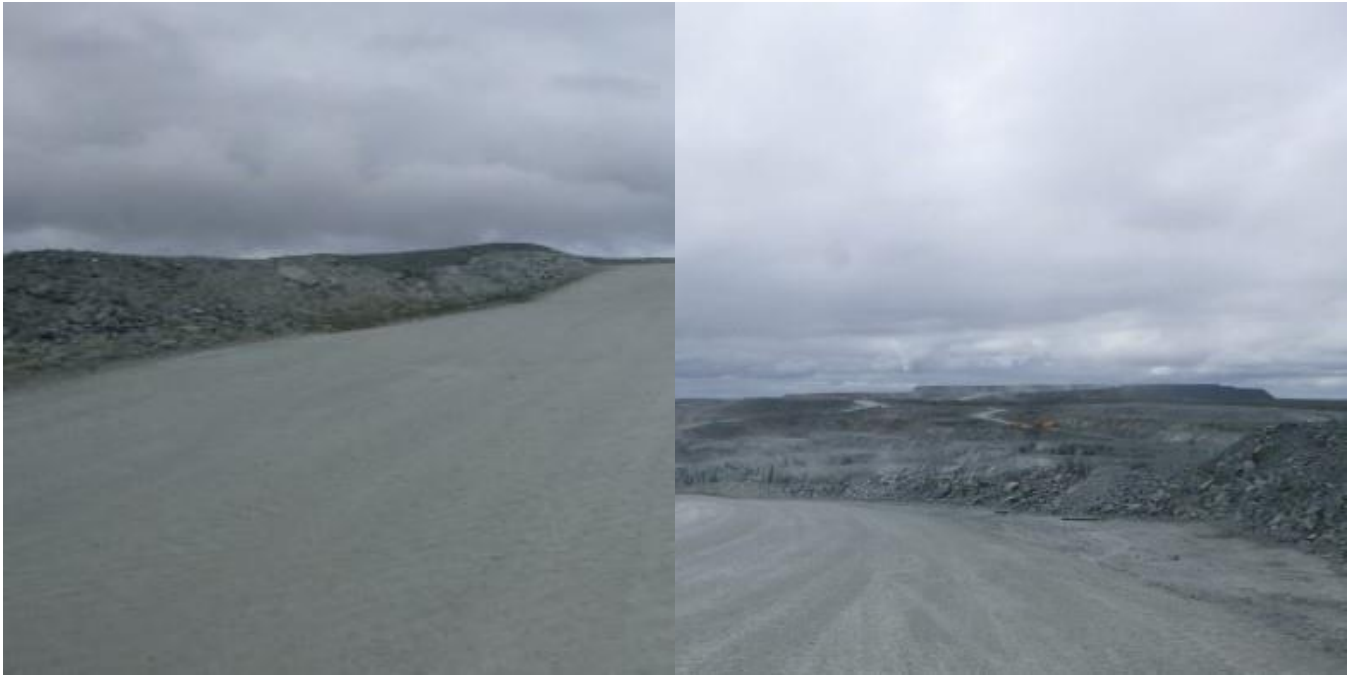
During operations at Whale Tail Pit project, a hoist cylinder on HTR32 failed, causing hydraulic oil to leak onto the ground. The spill occurred on the ramp of IVR pit.

Failed hydraulic hoist cylinder on HTR32.

The operator turned off the equipment and called maintenance. Contaminated material was collected and disposed of in the contaminated soil bin, to be disposed in the Meadowbank landfarm.

A routine visual inspection of all systems is performed during pre-operation checks as a part of the preventative maintenance program.
