## 2021-09-11 WTP 250L Diesel

GN reference #: 2021-393

Please find the following information as a follow up to the Spill report submitted September 12, 2021 by Agnico Eagle Meadowbank division. This detailed report is submitted to the Inspector in compliance with the conditions under the Nunavut Water Board License 2AM-WTP1830, Part H, Item 8c.

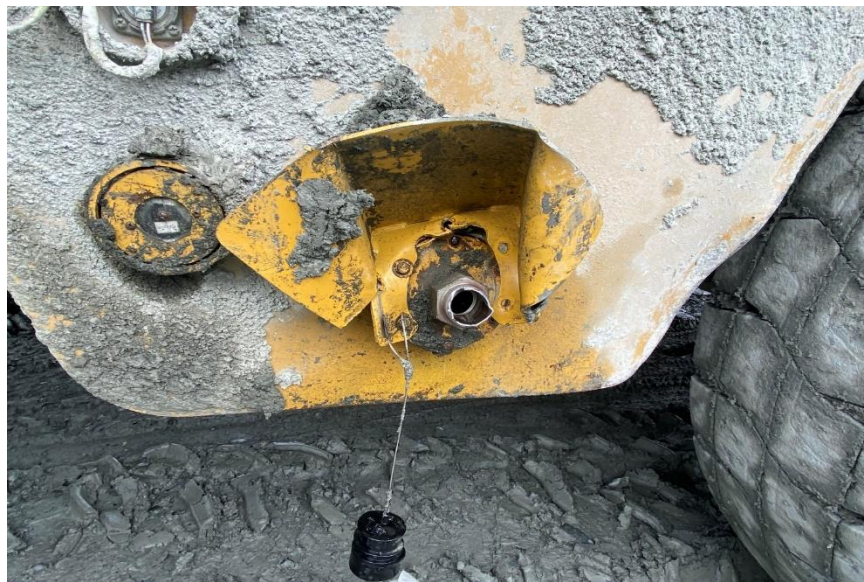
During operations in the IVR pit at Whale Tail Pit project, a rock contacted the gas cap on Haul Truck 04, damaging the fuel cap along with the top portion of the fuel tank and spilling diesel fuel on the IVR pit ramp.

Damaged Fuel cap and Fuel Tank on HTR04.

A reminder to operators to complete a 360 visual inspection of all work areas as part of the inspection phase prior to starting a task.

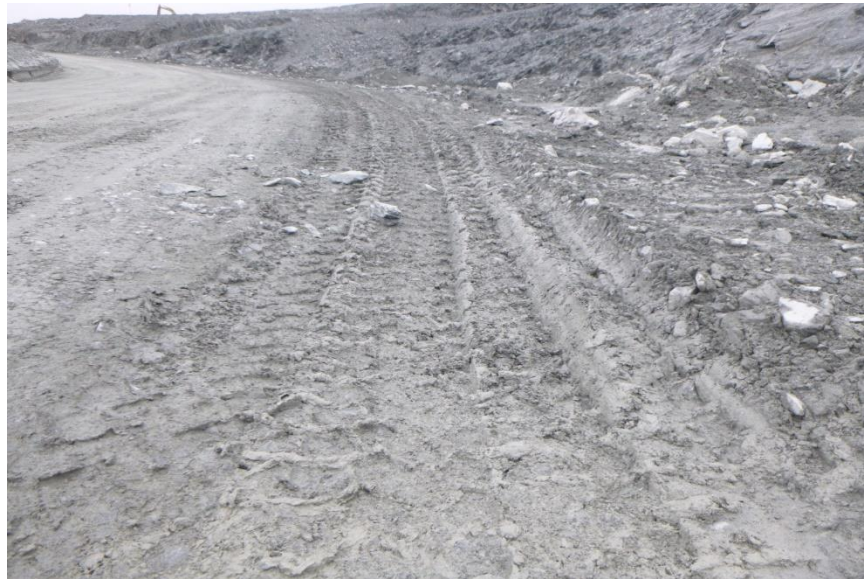
The operator turned off the equipment and called maintenance. The spill was contained by placing a half-cut drum under the leak, a small berm, along with spill pads. 20m<sup>3</sup> of Contaminated material was collected in a Haul truck and brought to the Meadowbank landfarm.
