2022-01-06 WTP 10L Sewage

GN reference #: 2022-006

Please find the following information as a follow up to the Spill report submitted January 6, 2022 by Agnico Eagle Meadowbank division. This detailed report is submitted to the Inspector in compliance with the conditions under the Nunavut Water Board License 2AM-WTP1830, Part H, Item 8c.

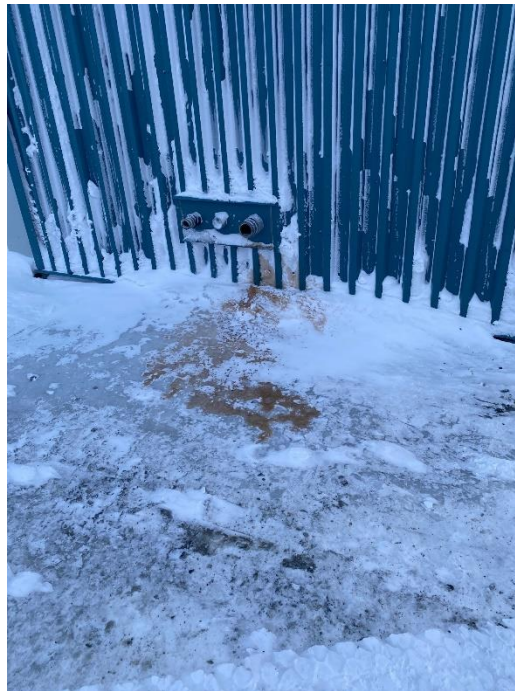
During the transfer of sewage between the emulsion facility offices and the sewage truck at the Whale Tail Pit Project, some blackwater residue leaked onto the ground under the connection through the action of disconnecting the hose.

Figure 1. Emulsion facility, dated January 6th

Inadequate manipulation of equipment by the operator.

Procedures in place for operating the equipment were reviewed with the vacuum truck operators and environmental awareness regarding reportable substances was reinforced.
