2022-02-03 WTP 4 m3 Grease

GN reference #: 2022-058

Spill Description

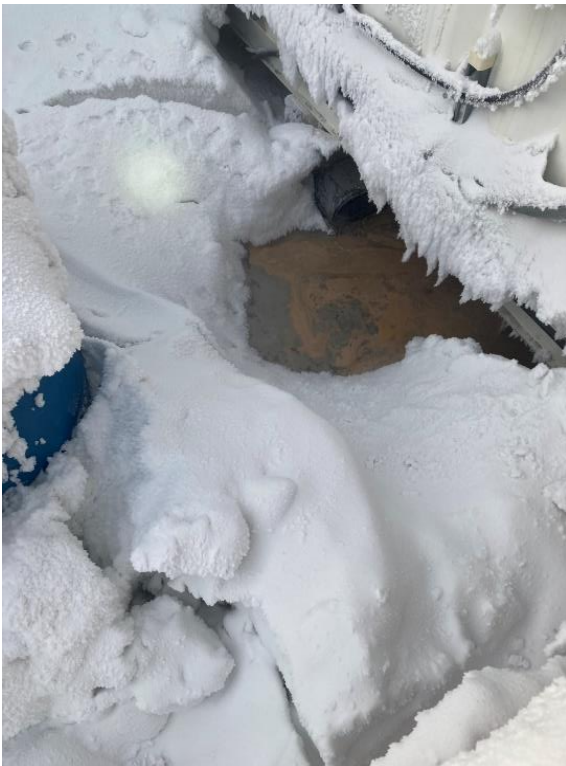
During operations at Whale Tail Pit project, a worker was performing a routine inspection of the Sewage Treatment Plant when they observed a spill of grease under the plant. Upon further investigation, the sump pipe that feeds the grease storage tanks was found to be broken. As result of the broken pipe the two grease tanks back flowed via gravity into the sump until it overflowed under the plant.

Figure 1. Grease spill from under the wing – 2022-02-03

Workers immediately used the sucker truck to remove ~1000L of grease from the ground. Hand shovels and equipment was used to clean the spill area. Approximately 1.5 m³ of contaminated snow and material was disposed of at the Meadowbank tailings area. Due to the location, time and nature of the spill additional remediation work will occur in the spring when the ground has thawed to allow for better recovery of contaminated material.

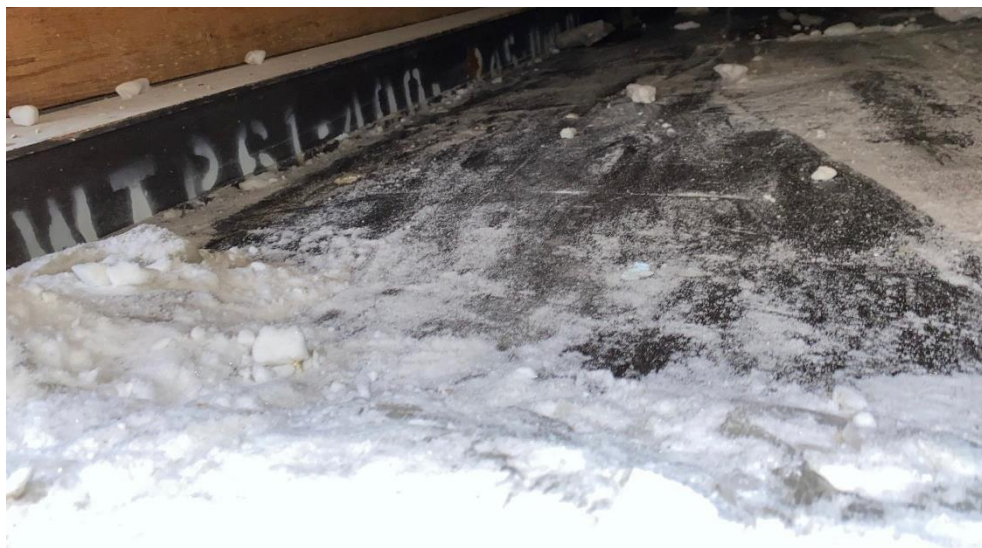
Figure 4. Grease Spill after cleanup efforts

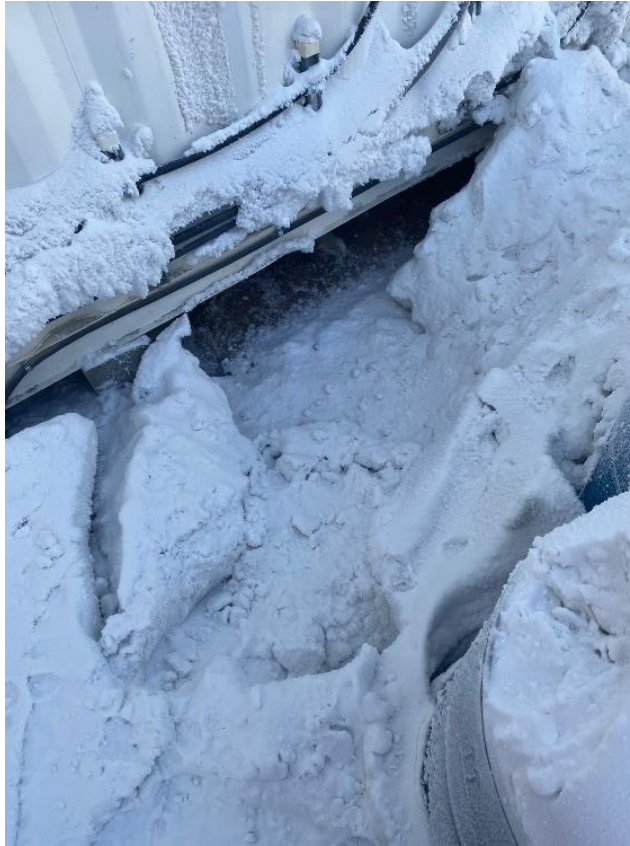
Figure 5. Grease Spill after cleanup efforts – 2022-02-05
