2022-02-11 WTP 5L STP Sludge

GN reference #: 2022-059

Please find the following information as a follow up to the Spill report submitted February 12, 2022, by Agnico Eagle Meadowbank division. This detailed report is submitted to the Inspector in compliance with the conditions under the Nunavut Water Board License 2AM-WTP1830, Part H, Item 8c.

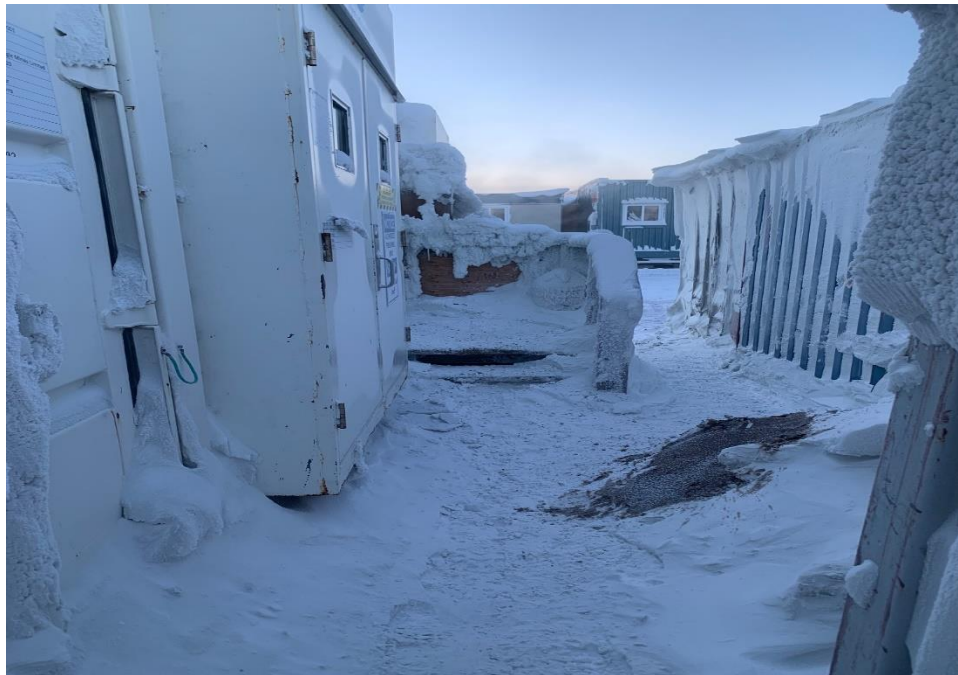
During operations at Whale Tail Pit project, a millwright was replacing the transfer pump at the Sewage Treatment Plant (STP). The overflow from the pump was placed into a pail and the contents were dumped onto the ground.

Spill location: 65°24'5.1"N 96°40'2.4"W on IOL.

There were no off-site impacts or discharge to any receiving watercourses. Distance to the closest water body is 320 meters to lake A-56.

Human error
