2022-03-19 WTP 250L Diesel

GN reference #: 2022-088

Please find the following information as a follow up to the Spill report submitted March 20, 2022, by Agnico Eagle Meadowbank division. This detailed report is submitted to the Inspector in compliance with the conditions under the Nunavut Water Board License 2AM-WTP1830, Part H, Item 8c.

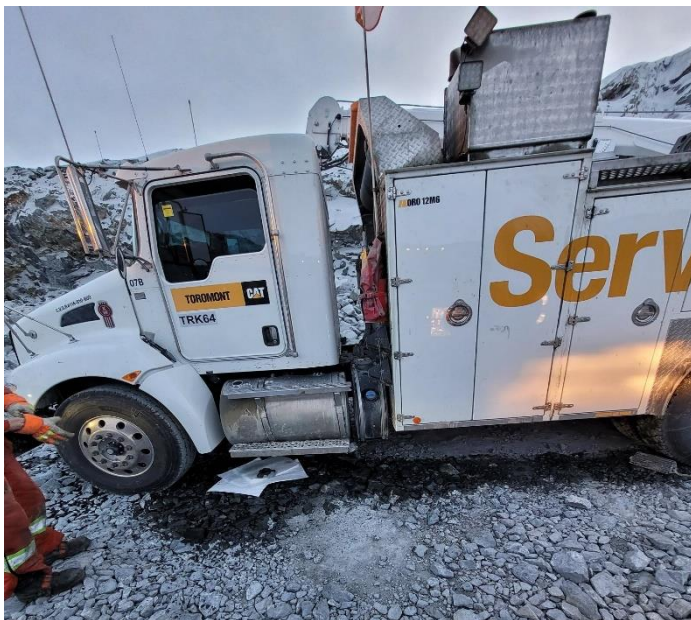
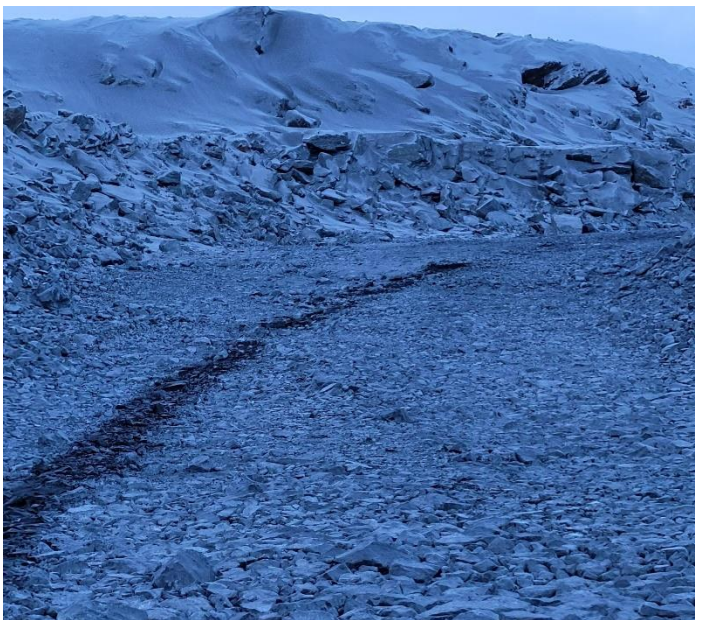
During operations at the Whale Tail pit project, the service truck ran over a rock while going up the IVR pit ramp. The rock tipped and ruptured the fuel tank causing fuel to spill onto the ground.

Human error

Operators are reminded to drive according to conditions and to advise the pit supervisor of any spill rock on the pit roads.
