2022-05-17 WTP 400L Hydraulic Oil

GN reference #: 2022-186

Spill Description

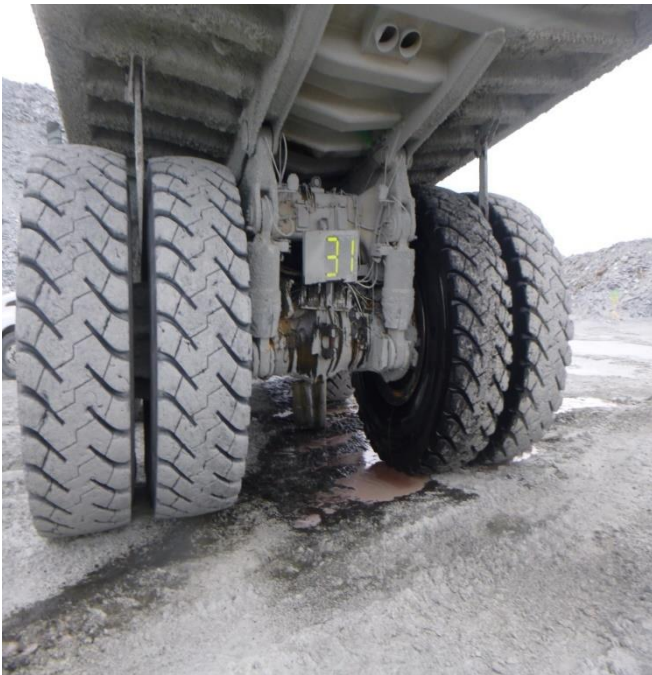
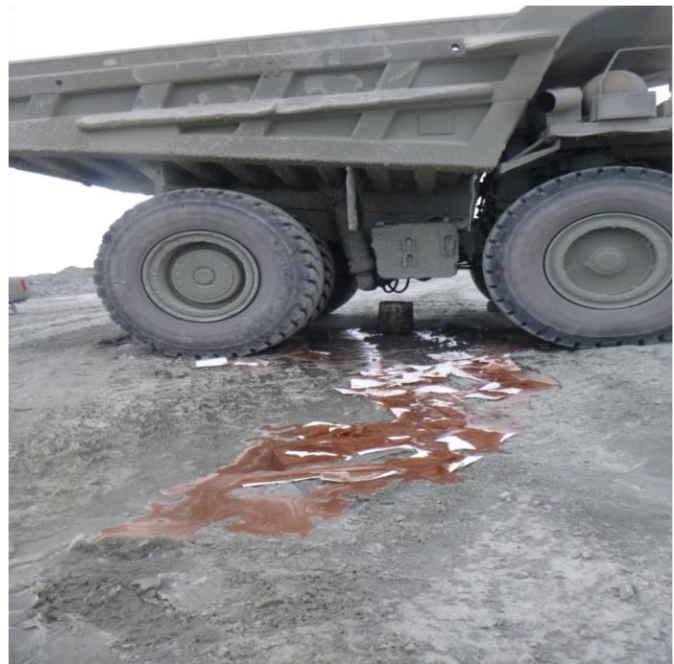
During operations at Whale Tail Pit project, a hydraulic hose of the haul truck failed causing a total of 400L of hydraulic oil to leak on the ground between IVR Rock Storage Facility main ramp and the heavy equipment parking.

Hydraulic Hose Failure

The mechanics immediately placed a secondary containment under the truck and placed down spill absorbent pads. The environment department was called to assess the spill. Approximately 10m³ of contaminated material was excavated and brought to the contaminated soil bin to be disposed of at the Meadowbank Landfarm.

A routine visual inspection of all systems is performed during pre-operation checks as a part of the preventative maintenance program.
