2022-05-17 WTP 1100L Diesel Fuel

GN reference #: 2022-186

Please find the following information as a follow up to the spill report submitted May 17, 2022, by Agnico Eagle Meadowbank division. This detailed report is submitted to the Inspector in compliance with the conditions under the Nunavut Water Board License 2AM-WTP1830, Part H, Item 8c.

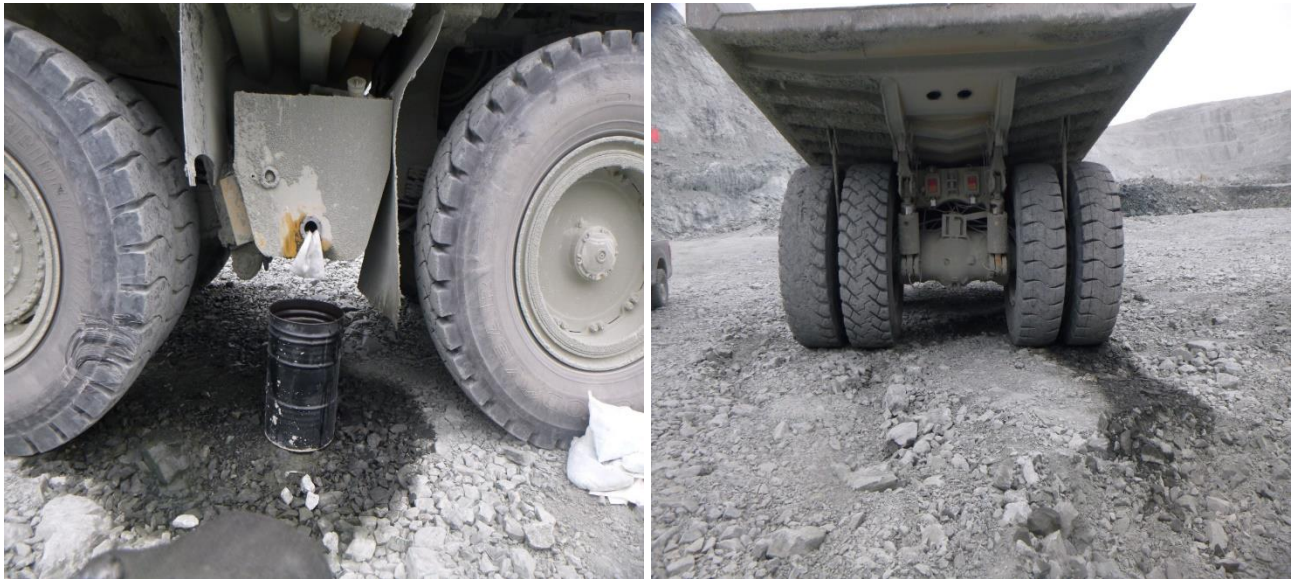
During loading operations at Whale Tail Pit project, a rock rolled off the dig face and struck the haul truck Wiggin's nozzle causing the fuel tank to spill on the floor of the Whale Tail pit.
