## 2022-06-07 MBK Baker Lake TSS

GN reference #: 2022-236

Please find the following information as a follow up to the spill report, #2022-236, submitted June 7, 2022 by Agnico Eagle Meadowbank division. This detailed report is submitted to the Inspector in compliance with the conditions under the Nunavut Water Board License 2AM-MEA1530, Part H, Item 8c and subsection 38(7) of the fisheries act.

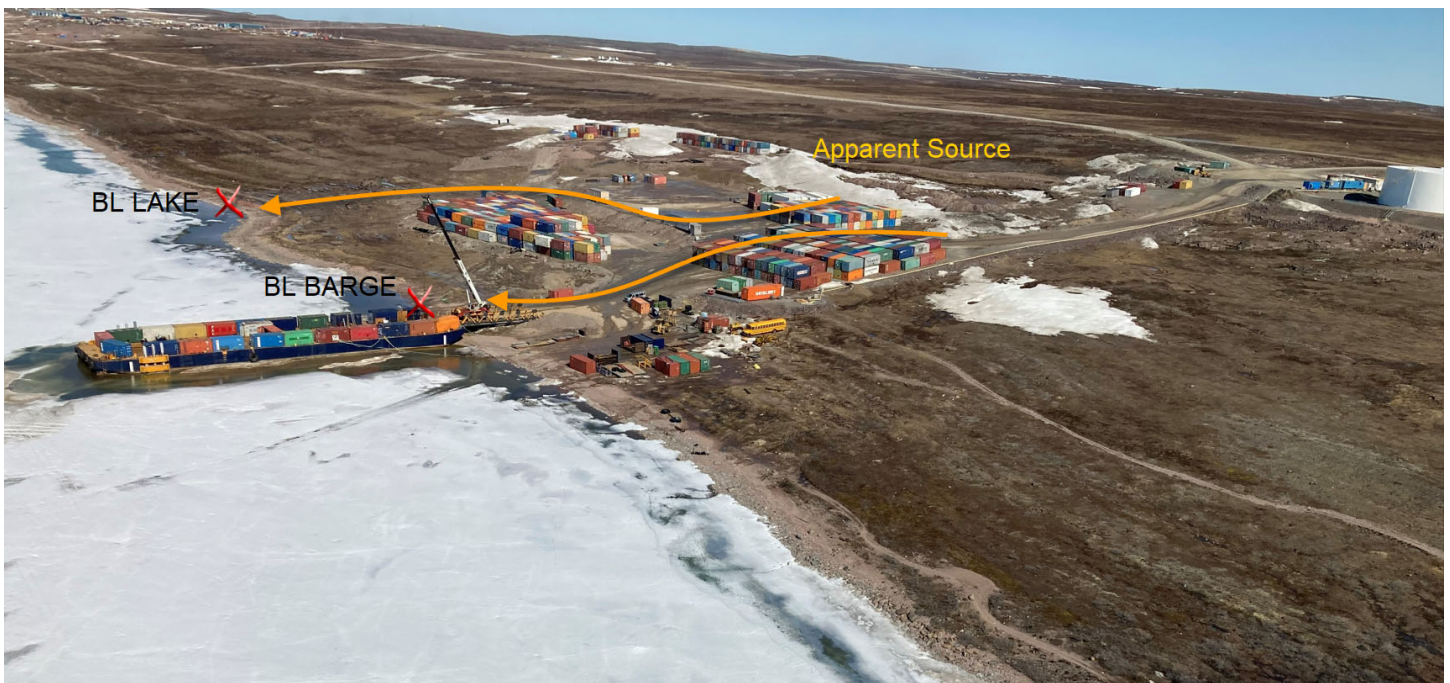
During an inspection of the Baker Lake Marshalling Facilities by an environmental technician, two turbid flows of water were observed entering into the thawed shore of Baker Lake, creating apparent plumes of TSS along the shore. The flows of water appeared to flow through the Agnico Eagle facilities, where heavy equipment were travelling to prepare the area for the upcoming maritime shipping season. The visible plumes in Baker Lake were mostly contained within a few feet from the shoreline, and water appeared clear a few meters into the lake. The two plumes are hereafter referred to as “BL-BARGE” for the flow of water that entered on the West side of the dock (64°18'17.68" N, 95°57'11.11" W), and “BL-LAKE” for the flow of water further West (64°18'20.23" N, 95°57'22.77"W). See figure 1 below for general site layout information and flow path estimate.

*Figure 1. Overall Layout - Aerial Picture (2022/06/07)*

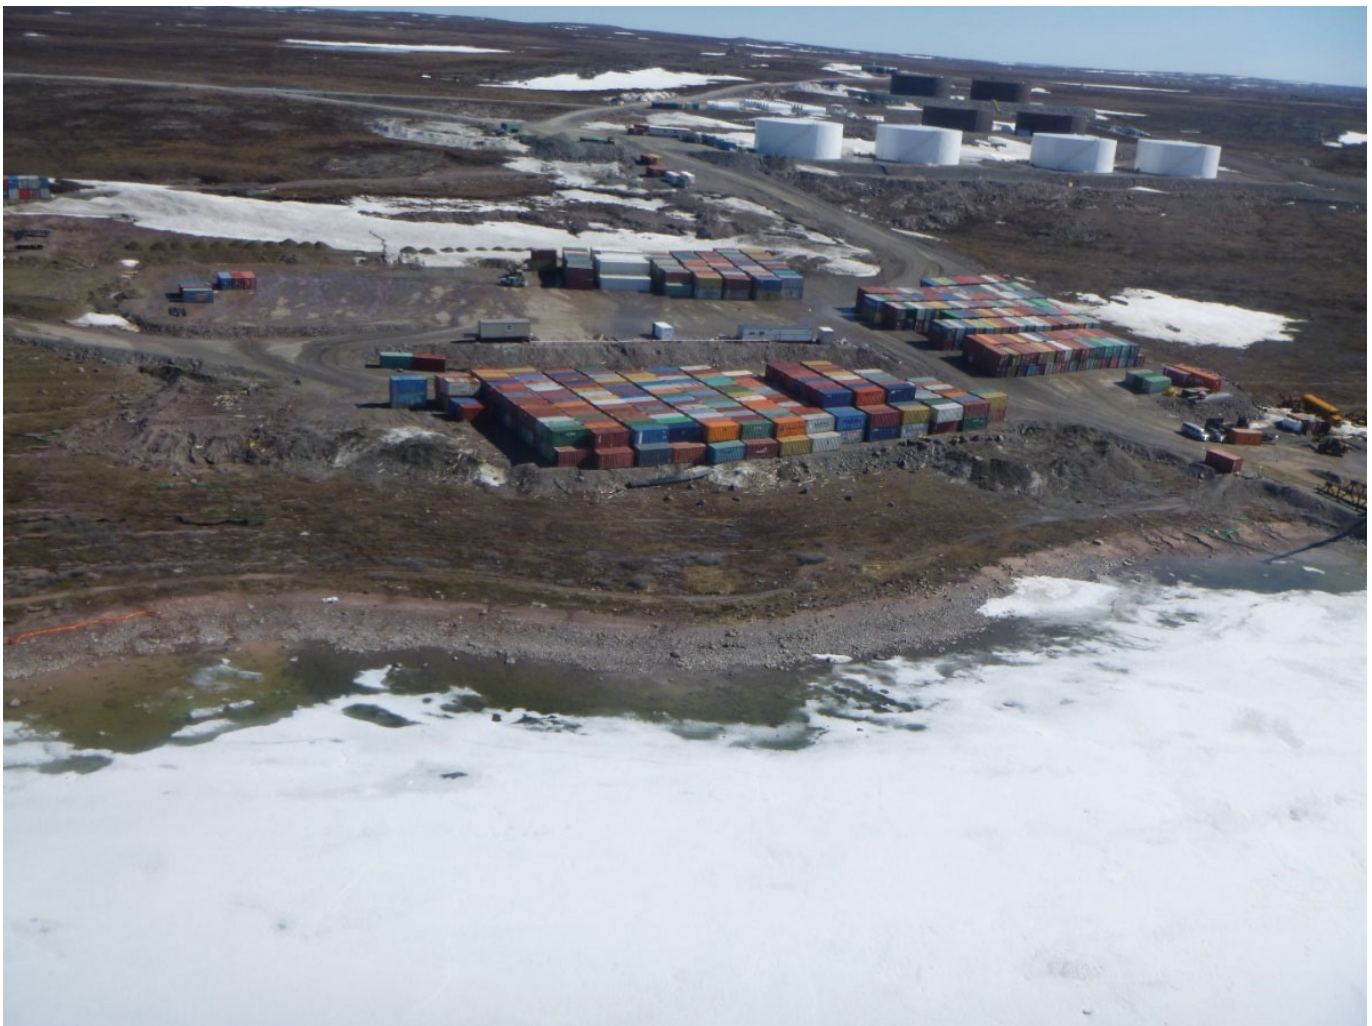
*Figure 2. Aerial view of Baker Lake Shore prior to deployment of maritime booms (2022/06/07)*

The identified cause for the turbid runoff is the large volume of water reporting through the Marshalling Facilities without sufficient control measures in place. The volume of water flows through exposed till material, from which sediments are transported towards the lake. Furthermore, poor snow management practices during the winter of 2021-2022 allowed for little room for sedimentation to occur in the runoff water.

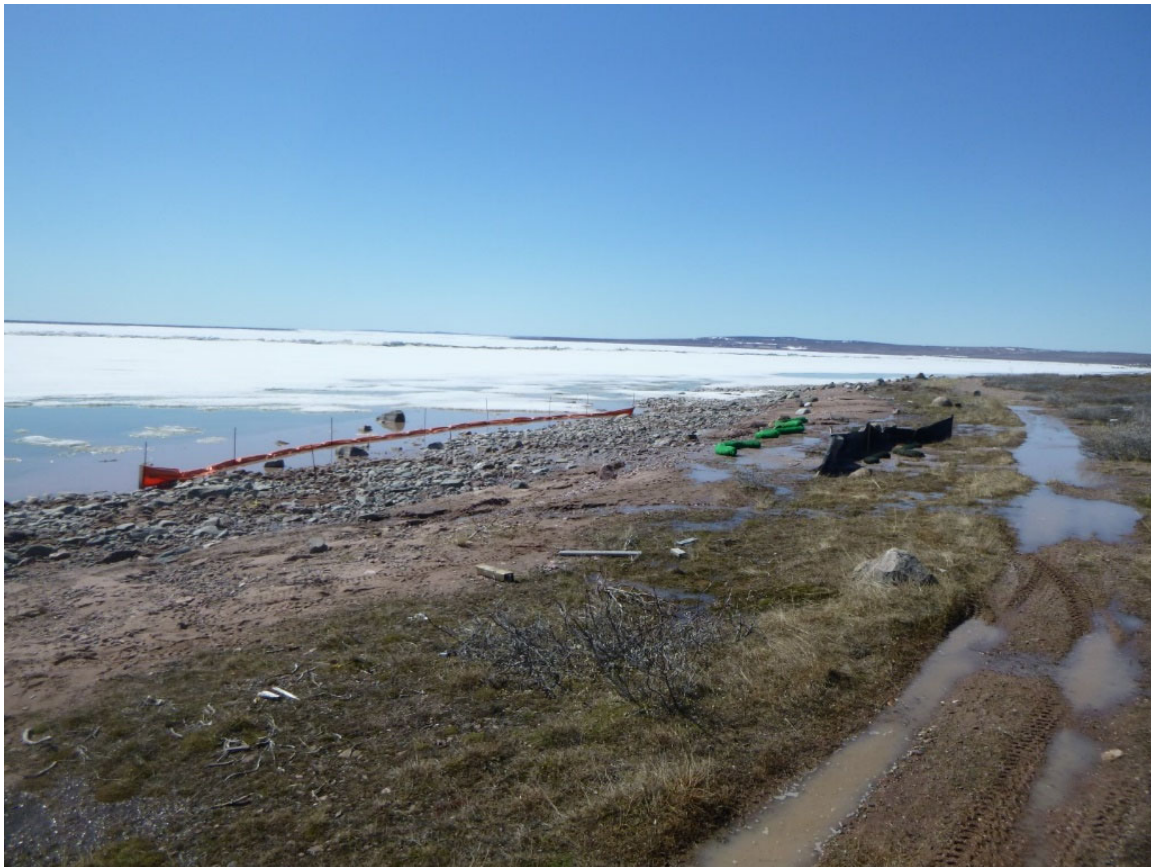
*Figure 3. Mitigation Measures at BL-LAKE (2022/06/07)*

Upon observation of the runoff into the lake, the environmental personnel deployed maritime curtains, woodchip-log or straw-log booms and silt fence in the flow path of the runoff, to control the transportation of sediments. Over the next week, daily inspections and monitoring of the sector was performed by environmental staff. During the monitoring, the TSS control measures were monitored, repaired and added, if needed. Samples of the water quality (total suspended solids) of the lake at both inflow locations were taken, as described in Table 1. Acute Lethality sample results are pending final analysis. As part of the Core Receiving Environmental Monitoring Program, water chemistry monitoring will occur in Baker Lake.

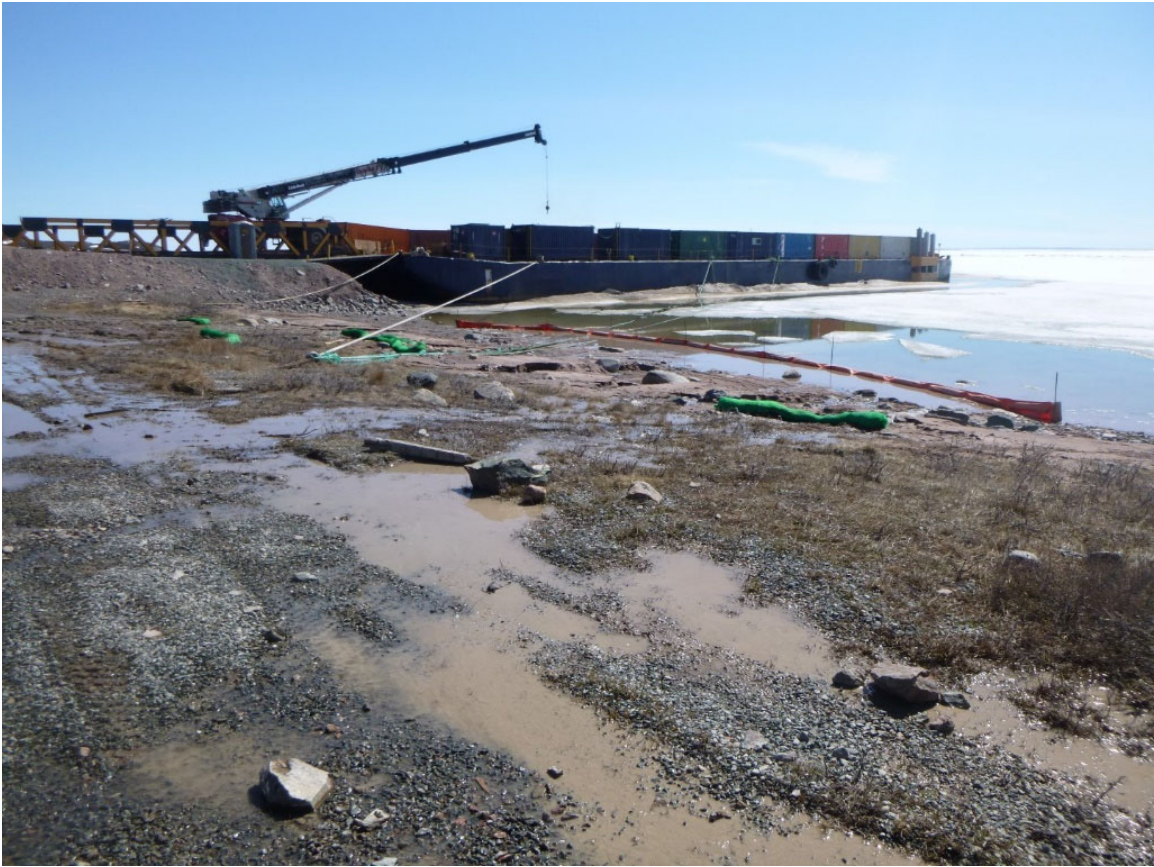
*Figure 4. Mitigation Measures at BL-BARGE (2022/06/07)*

From Figure 4, it is possible to see the effectiveness of the barriers to contain the turbidity in a localized area. The lakebed can also be seen to have apparent additional sediments. From figures 6 and 7, it is possible to see the effectiveness of the measures as of June 30<sup>th</sup>, with little to no water reporting to the lake. The area will require close monitoring following each rain events.

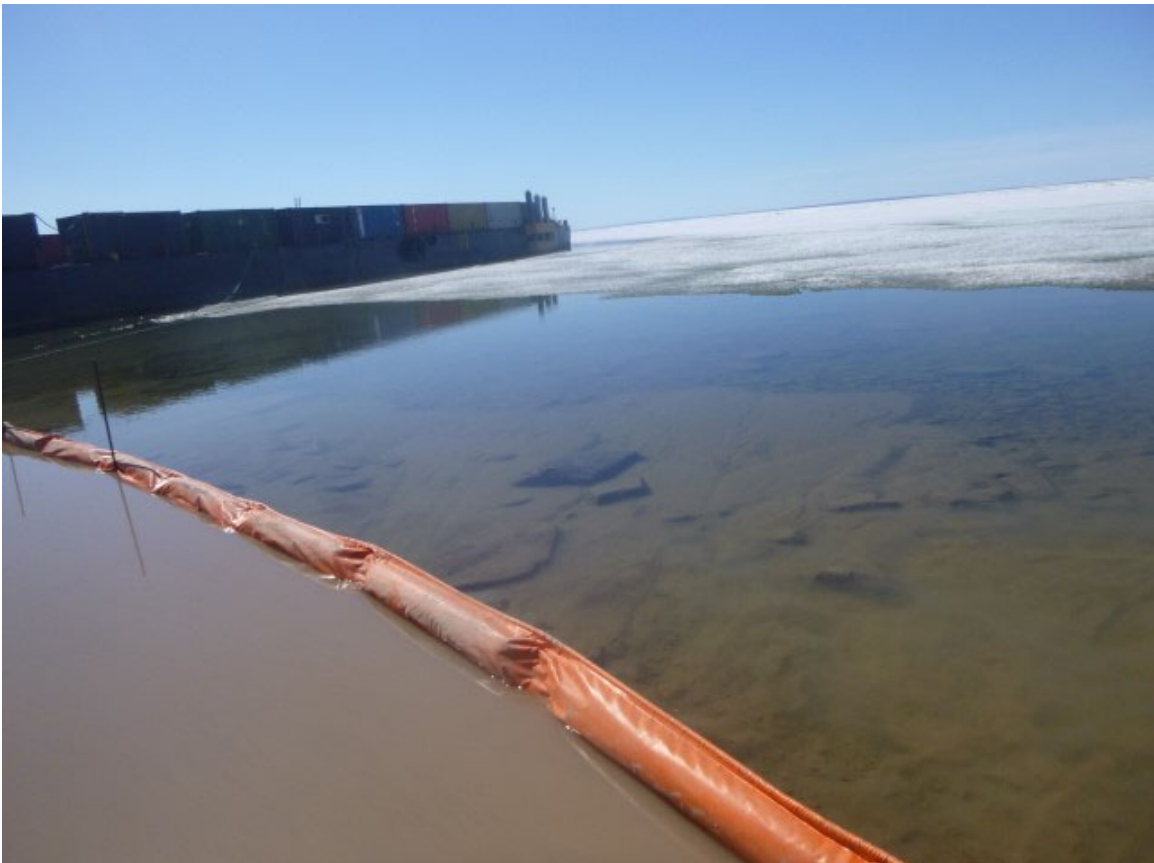
*Figure 5. Contained turbidity & sediments at BL-BARGE (2022/06/10)*

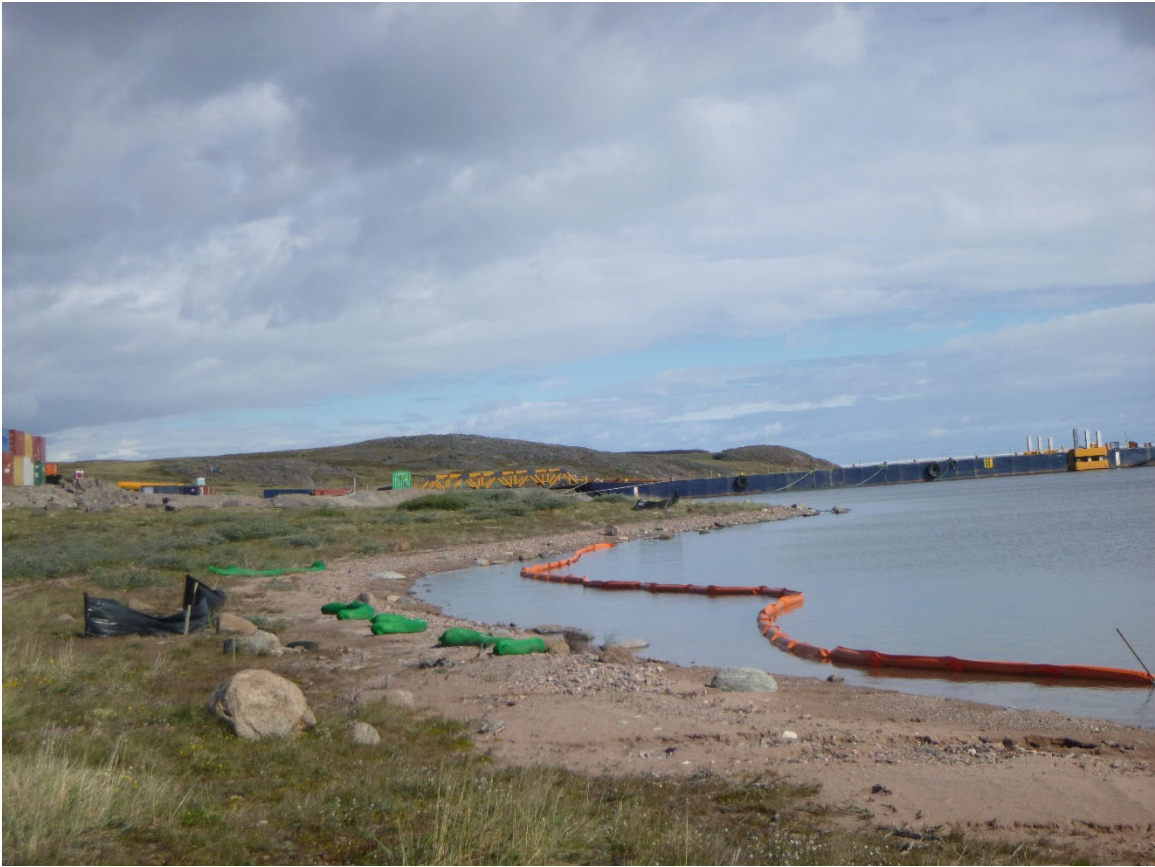
*Figure 6. BL-LAKE (2022/06/30)*

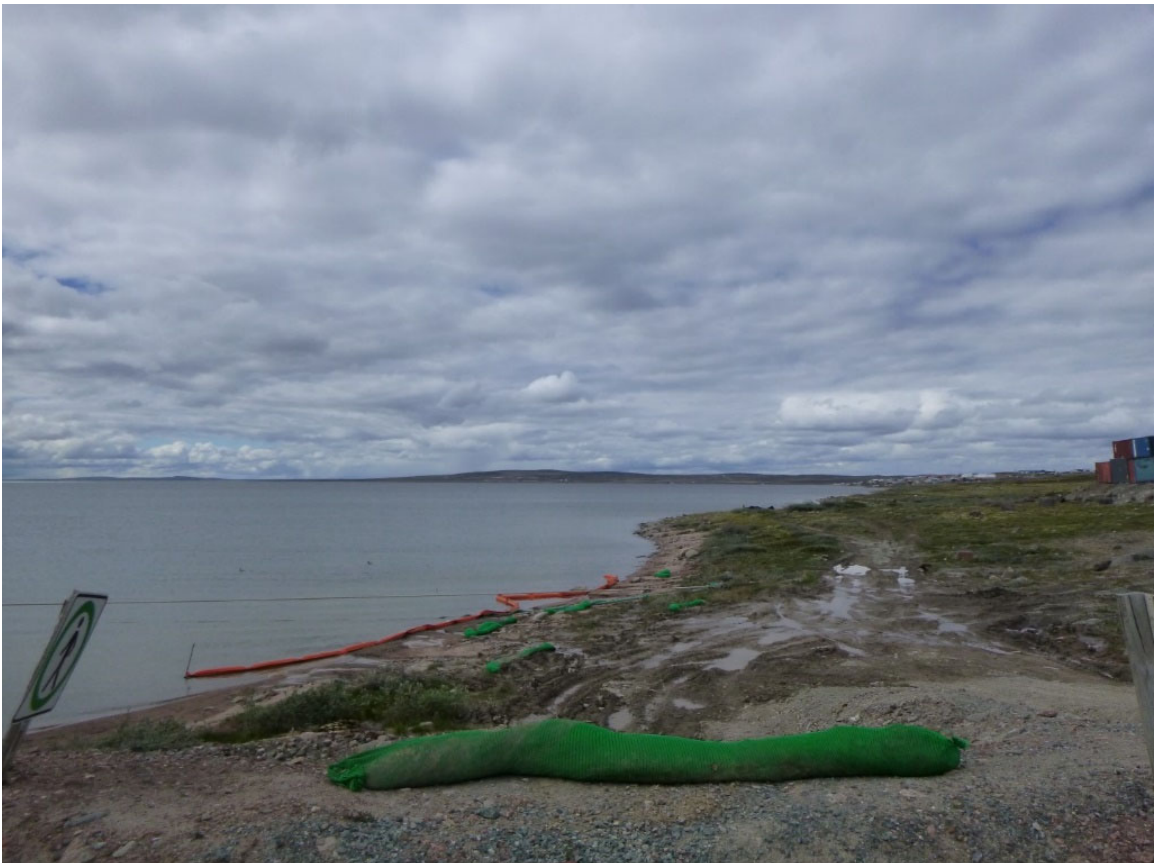
*Figure 7. BL-BARGE (2022/06/30)*
