2022-08-03 WTP 50L Sewage

GN reference #: 2022-396

Spill Description

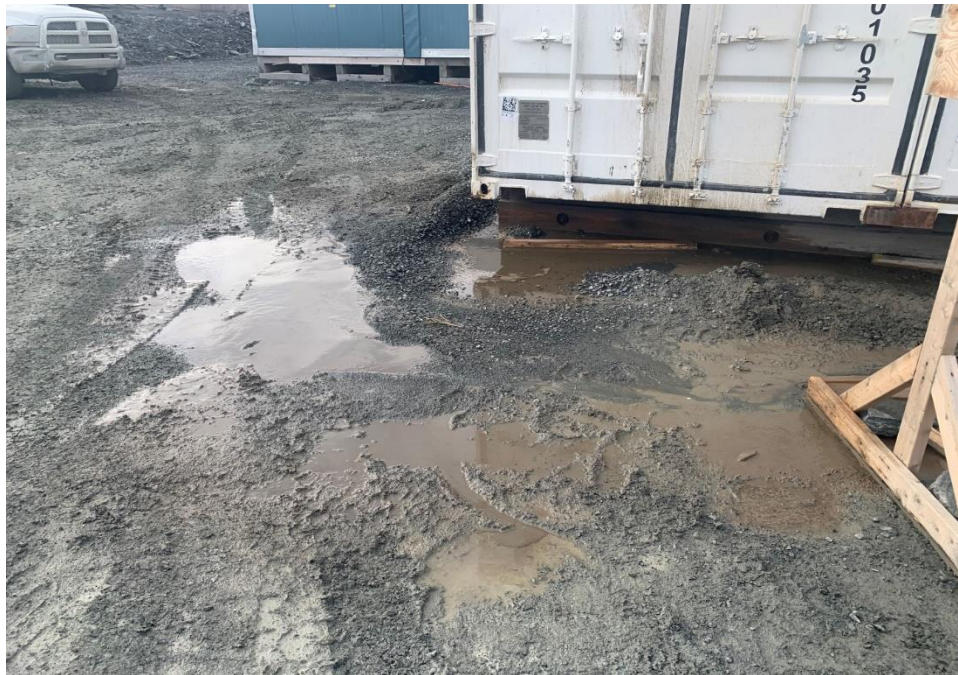
During operations at the Whale Tail pit project, a planned electrical shutdown occurred on August 2, 2022. During the start of dayshift on August 3, 2022 – the sewage treatment plant operator noticed the sewage overflow from MBR3 in the STP.

Spill location: 65°24'4.86"N 96°40'1.94"W on IOL.

The vacuum truck was used to collect any sewage sludge that had pooled on the surface. A small excavator and hand shovels were used to scrape the ground. Approximately 2m³ of contaminated material was collected.

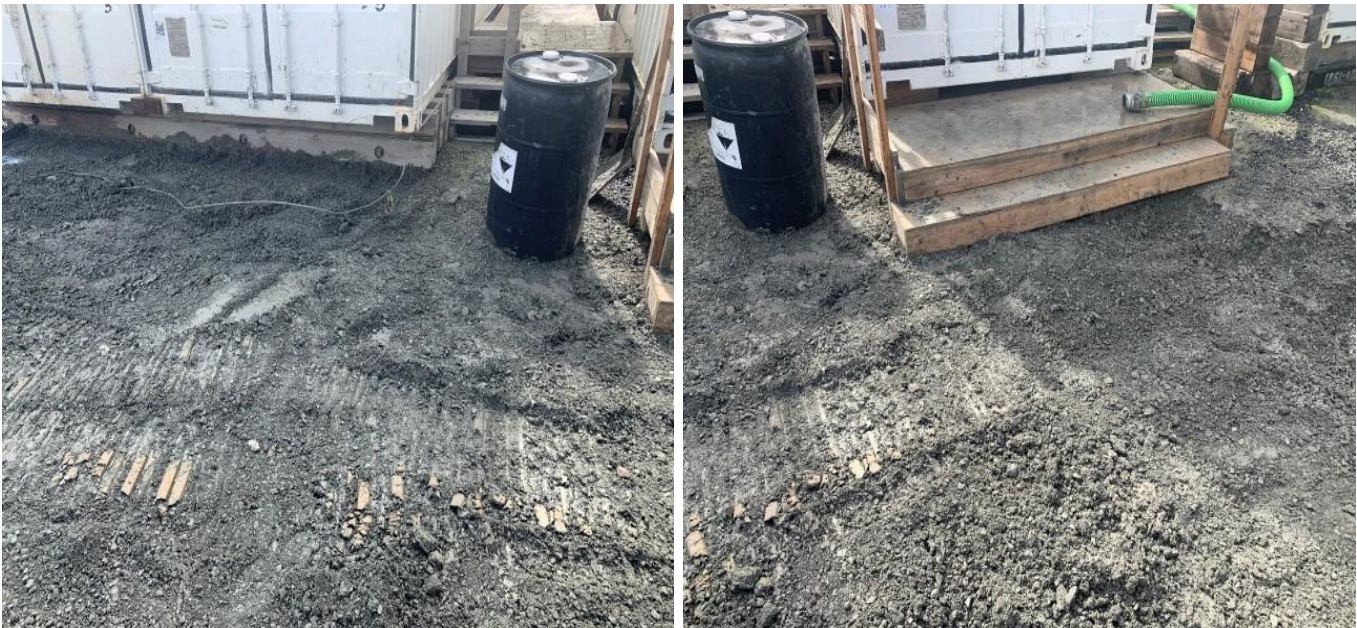
It was determined the level probe and float failed during start up after the electrical shut down.

Sewage Treatment Plant Operators will complete a walk through and check of working areas after electrical shutdowns or power failures.
