## 2022-11-07 WTP 220L Hydraulic Oil

GN reference #: 2022-522

Please find the following information as a follow up to the Spill report submitted November 8<sup>th</sup>, 2022, by Agnico Eagle Meadowbank division. This detailed report is submitted to the Inspector in compliance with the conditions under the Nunavut Water Board License 2AM-WTP1830, Part H, Item 8c.

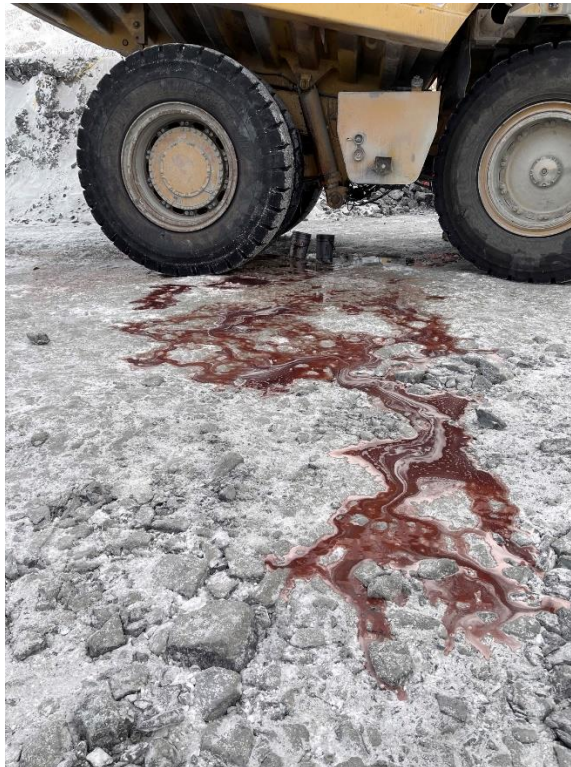
Spill Location: Northing: N 65°24'12.07" W 96°42'19.26" on IOL

During operations at the Whale Tail Project, the drive shaft failed on a haul truck causing a total of 220L of hydraulic oil to spill on to the ground at the bottom of Phase 1 in the Whale Tail Pit.

There were no off-site impacts or discharges. Distance to the closest water body is 775m to Mammoth Lake

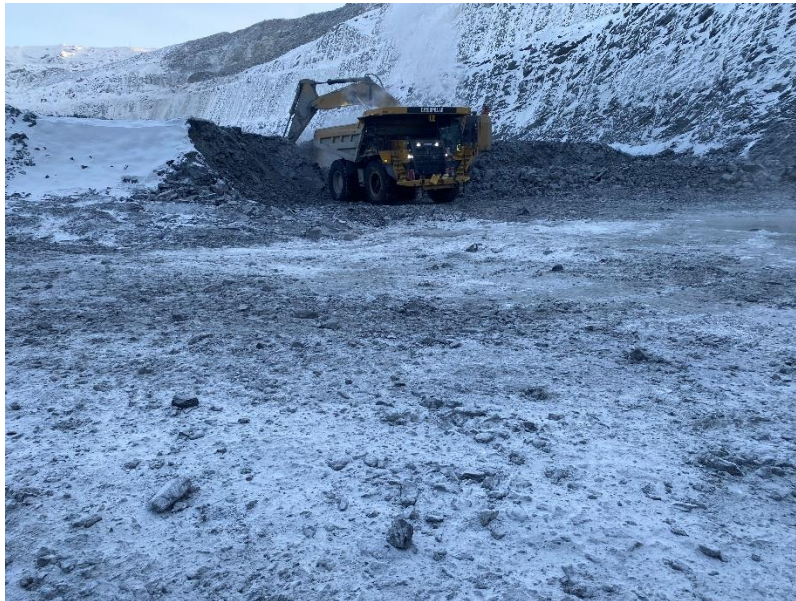
The equipment was immediately shut off by the operator and mechanics were called to have the equipment fixed. Approximately 4 m3 of contaminated materials has been collected and will be brought to the Meadowbank Landfarm.

A routine visual inspection of all systems is performed during pre-operation checks as a part of the preventative maintenance program.
