2022-11-23 WTP 20L Sewage

GN reference #: 2022-537

Please find the following information as a follow up to the Spill report submitted November 24th, 2022, by Agnico Eagle Meadowbank division. This detailed report is submitted to the Inspector in compliance with the conditions under the Nunavut Water Board License 2AM-WTP1830, Part H, Item 8c.

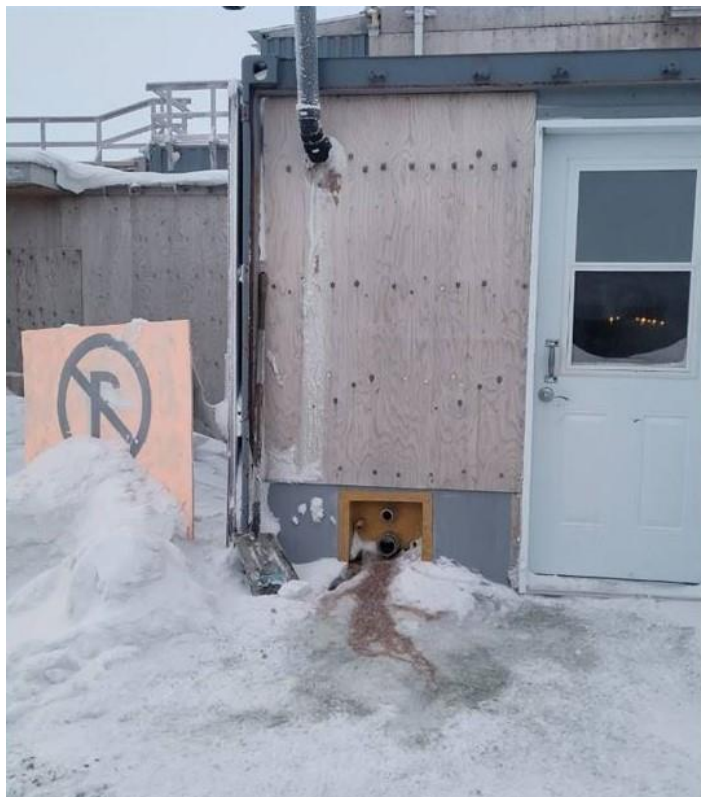
During an inspection of the Amaruq camp, a small quantity of frozen sewage was observed on the ground near the sewage transfer pipe.

Spill Location: N 65°23'59.1" W 96°40'37.2" on IOL

Human Error

AEM will install protective caps on all sewage discharge outlets. AEM will follow best spill practices and ensure vacuum truck operators install secondary containment at the discharge outlets when collecting sewage.

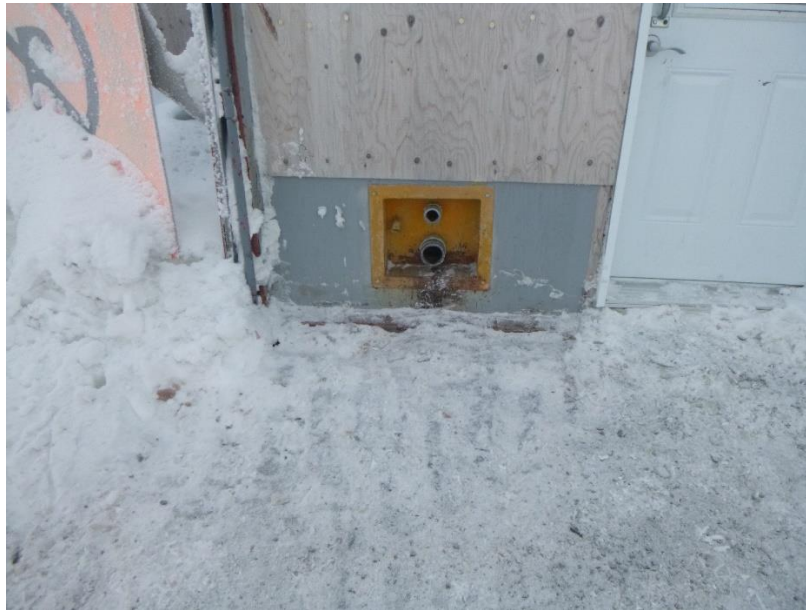
Approximately 1m³ of contaminated snow and sewage was collected and brought to the Meadowbank tailings area for disposal.
