## 2022-11-24 WTP 150L Diesel Fuel

GN reference #: 2022-539

Please find the following information as a follow up to the Spill report submitted November 24<sup>th</sup>, 2022, by Agnico Eagle Meadowbank division. This detailed report is submitted to the Inspector in compliance with the conditions under the Nunavut Water Board License 2AM-WTP1830, Part H, Item 8c.

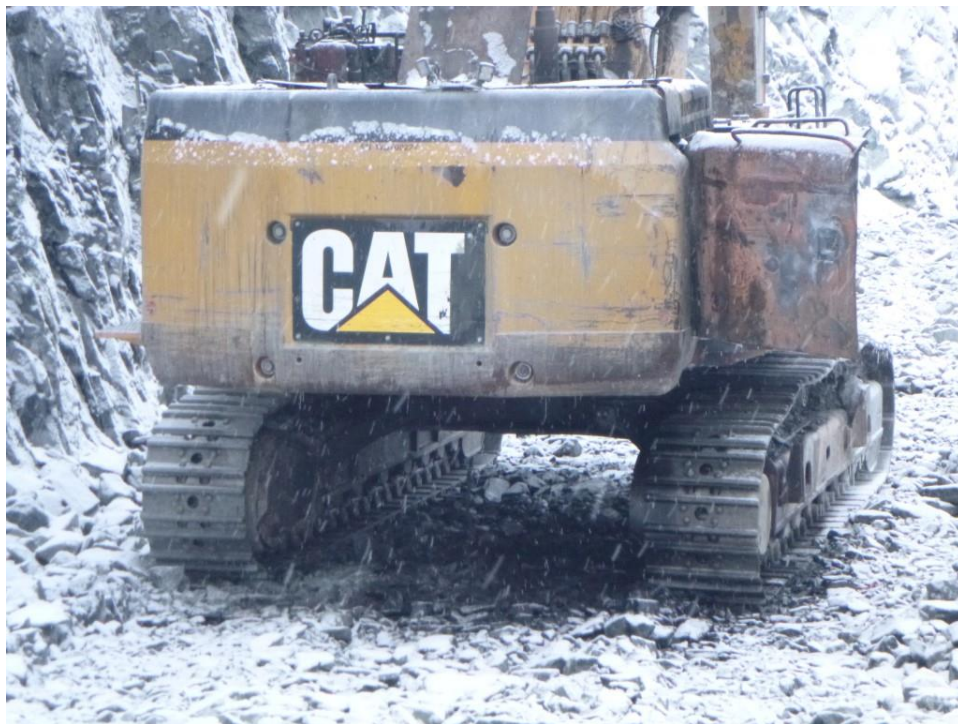
During operations at the Whale Tail pit project, the excavator was performing work in Whale Tail pit phase 3 when it caught fire. The Emergency Response Team was called to put out the fire.

Spill Location: Northing: N65° 24' 06.0" W96° 42' 26.8" on IOL

There were no off-site impacts or discharges. Distance to the closest water body is 650 m to Mammoth Lake

Fire originating from the engine compartment
