2022-12-13 WTP 100L Sewage

GN reference #: 2022-551

Spill Description

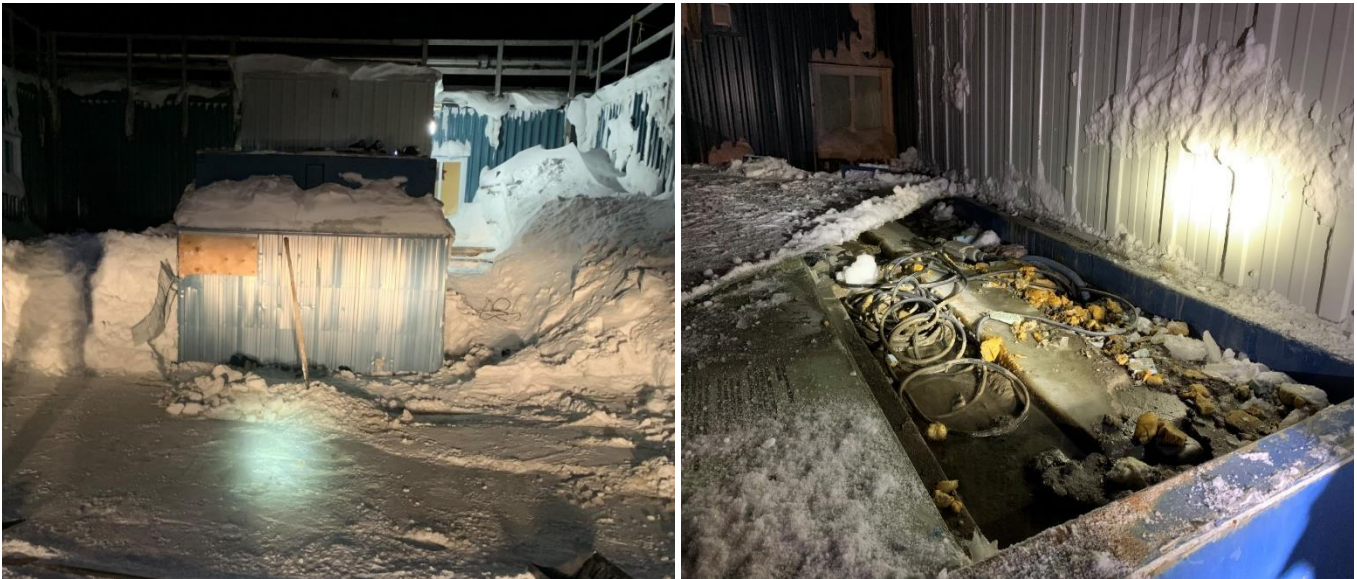
During operations at the Whale Tail pit project, the electrical float on the sewage lift station between wing 15 and wing 16 failed causing an overflow of the sewage tank.

Mechanical failure of the float and damage to the secondary containment under the sewage tank.

AEM will install a high sewage level alarm on the lift stations. The secondary containment on the lift station will also be replaced.

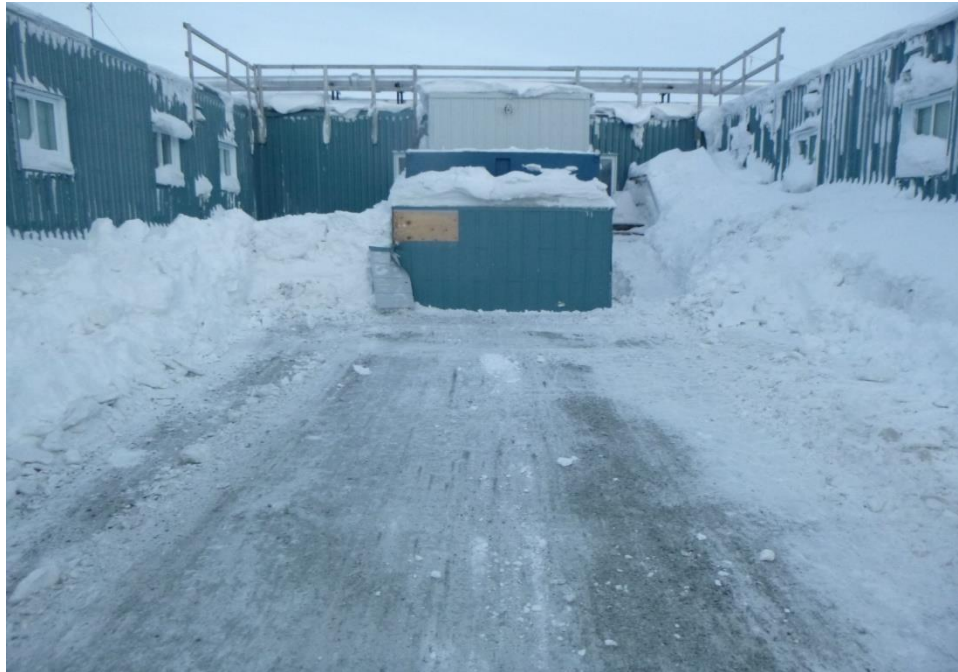
Approximately 4m³ of contaminated snow and sewage was collected and brought to the Meadowbank tailings area for disposal.
