2023-02-24 WTM 175L Hydraulic Oil

GN reference #: 2023-065

Spill Description

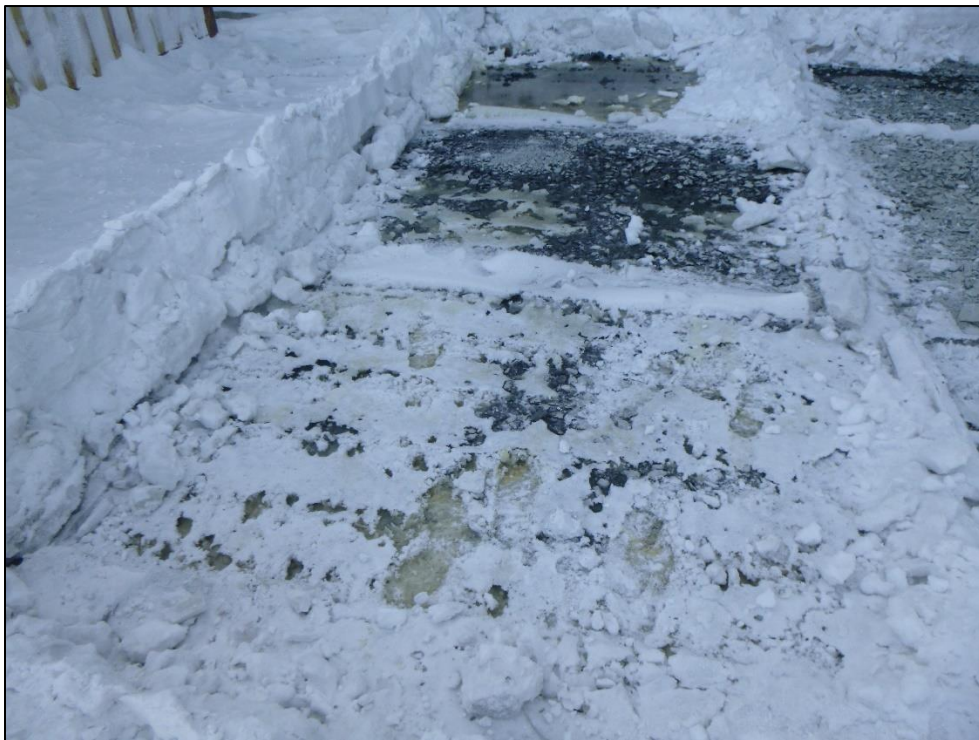
During operations at the Whale Tail Mine, a drum containing 205L of hydraulic oil was punctured by the equipment forks while manipulating the pallet of barrels inside a sea can. Ultimately, a portion of the oil seeped through the floor and leaked onto the ground of the warehouse pad.

Punctured drum caused by the equipment forks.

The procedure for handling of totes and drums is in the process of being updated and will be shared with all departments that manipulate totes and drums. A new camera system has been installed on equipment forks and its process is still being optimized.
