2023-03-06 WTM 150L Waste Oil

GN reference #: 2023-080

Please find the following information as a follow up to the Spill report submitted March 7th, 2023, by Agnico Eagle Meadowbank division. This detailed report is submitted to the Inspector in compliance with the conditions under the Nunavut Water Board License 2AM-WTP1830, Part H, Item 8c.

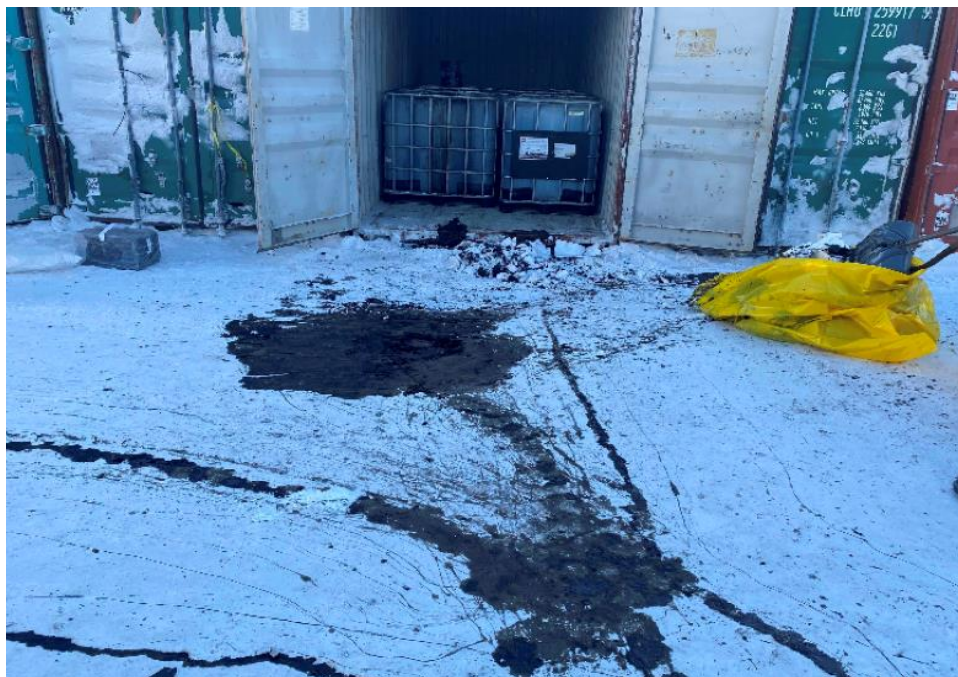
During operations at the Whale Tail Mine, a loader operator was placing waste oil totes into a seacan when they noticed the corners of both totes were leaking onto the ground.

Punctured/damaged tote caused by the equipment forks.
