2023-03-11 WTM 100L Waste Oil

GN reference #: 2023-089

Please find the following information as a follow up to the Spill report submitted March 12th, 2023, by Agnico Eagle Meadowbank division. This detailed report is submitted to the Inspector in compliance with the conditions under the Nunavut Water Board License 2AM-WTP1830, Part H, Item 8c.

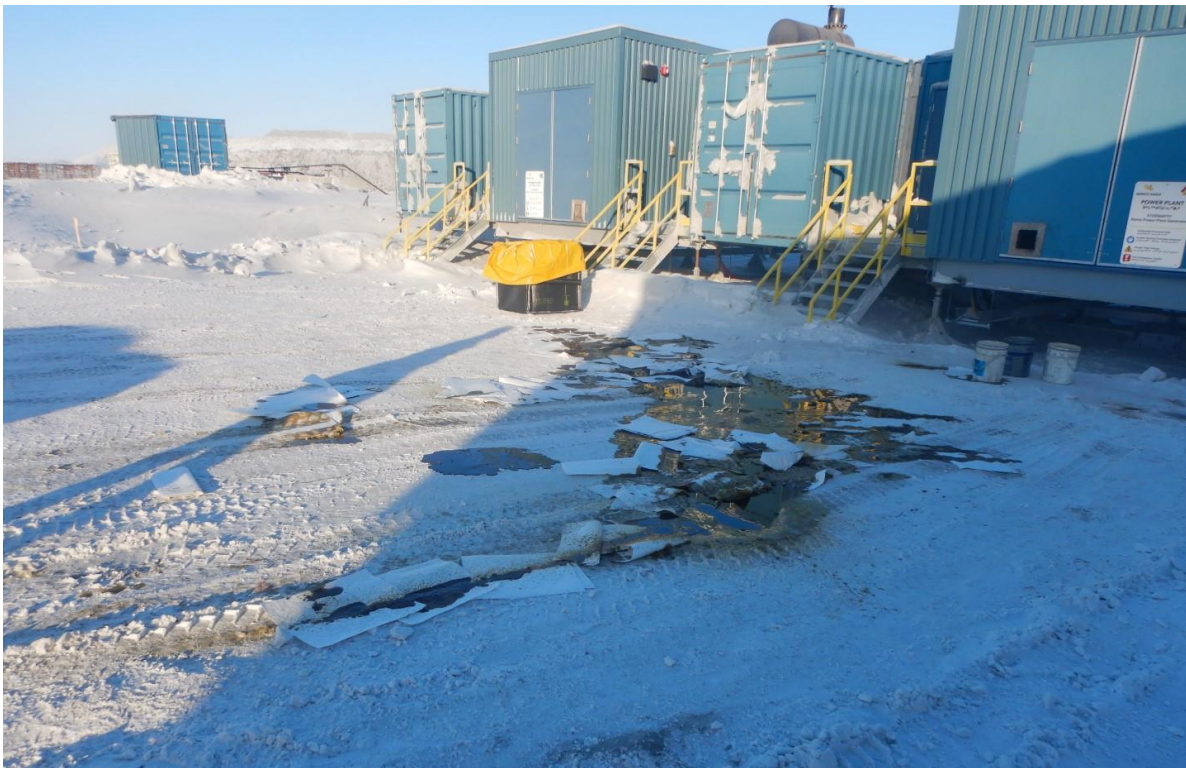
During operations at the Whale Tail Mine, a worker was draining the oil from GENSET07 into a tote. The worker went inside the GENSET enclosure and when they returned to the tote, it was overflowing into the maintenance truck and onto the ground.

Spill Location: 65°24'24.23"N 96°40'53.11"W on IOL

There were no off-site impacts or discharges. Distance to the closest water body is 1000M to lake A56.

Human Error

The work procedure will be updated to include a checklist for performing this task. Totes being used as a transfer container will require a secondary containment system in place. The procedure will be shared with all departments that perform similar tasks.
