2023-03-14 WTM 200L Diesel Fuel

GN reference #: 2023-096

Spill Description

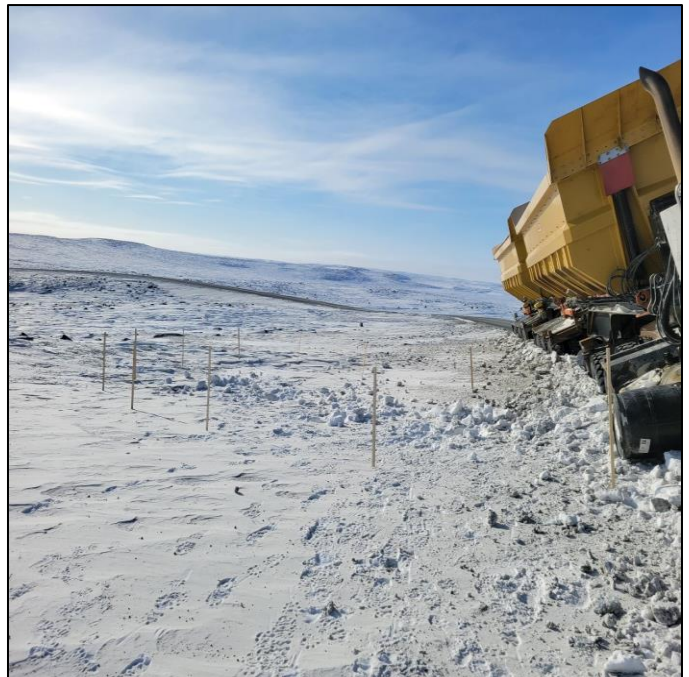
During operations at the Meadowbank complex, a Long Haul truck (LHT) was traveling northbound on the Whale Tail Haul Road and yielded right of way to a loaded southbound LHT. The operator of the northbound LHT was too close to the shoulder of the road and was pulled into the snowbank off the road. Upon investigation, a fuel leak from the filler neck on the side fuel tank was observed.

Human Error

A standdown was held with both LHT crews and the Whale Tail Haul Road Procedure was reviewed.
