2023-04-07 WTM 400L Coolant

GN reference #: 2023-140

Please find the following information as a follow up to the Spill report submitted April 8th, 2023, by Agnico Eagle Meadowbank division. This detailed report is submitted to the Inspector in compliance with the conditions under the Nunavut Water Board License 2AM-WTP1830, Part H, Item 8c.

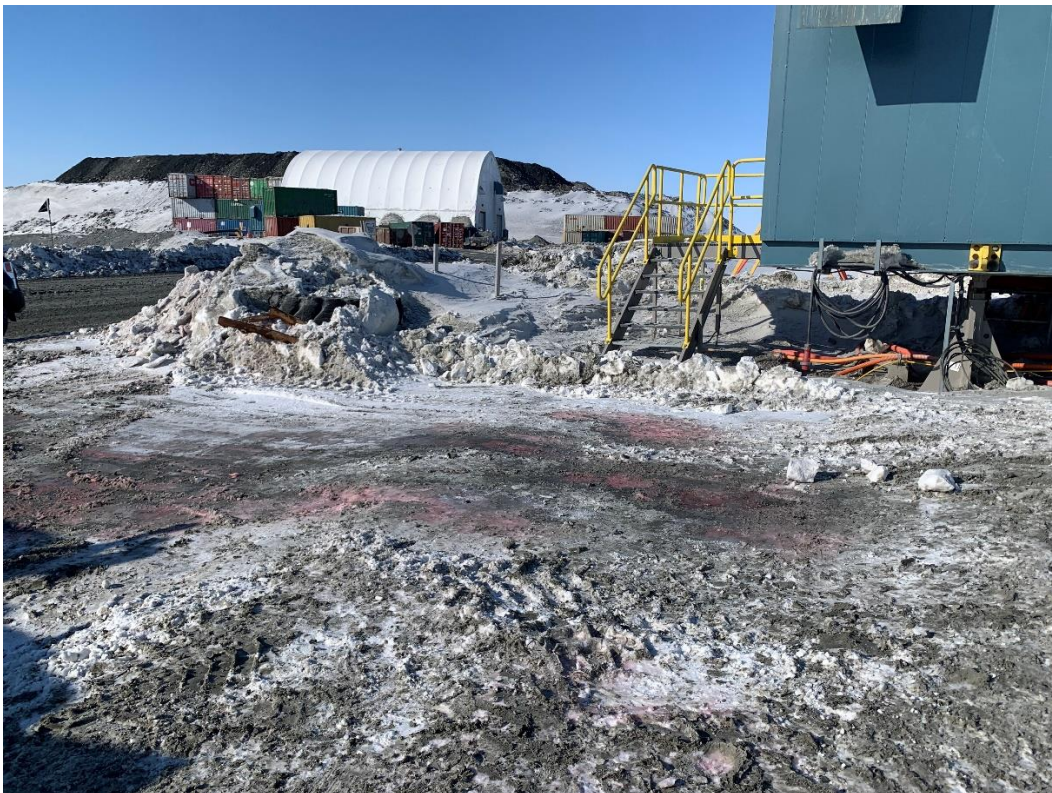
During operations at the Whale Tail Mine, an operator went to move a tote of coolant with a skid steer and punctured the tote with the forks causing the tote to leak on the ground. The operator placed the tote on its side to stop the leak.

Punctured tote caused by misalignment of the equipment forks.

Checklist for performing work is being updated. Totes being used as a transfer container will require a secondary containment system in place. Tote handling procedure being updated/implemented. Once completed, the procedure will be shared with the appropriate departments.

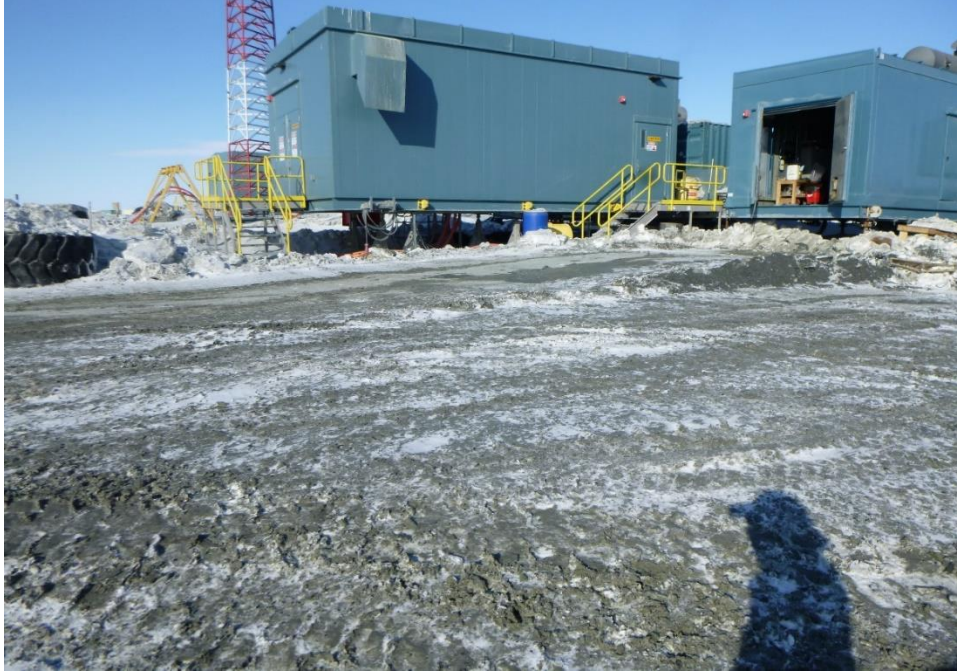
A loader equipped with a bucket was immediately used to excavate the contaminated area. Approximately 10m³ of contaminated snow and material was collected and disposed at the Meadowbank Tailings.
