2023-04-19 WTM 500L Hydraulic Oil

GN reference #: 2023-152

Please find the following information as a follow up to the Spill report submitted April 19th, 2023, by Agnico Eagle Meadowbank division. This detailed report is submitted to the Inspector in compliance with the conditions under the Nunavut Water Board License 2AM-WTP1830, Part H, Item 8c.

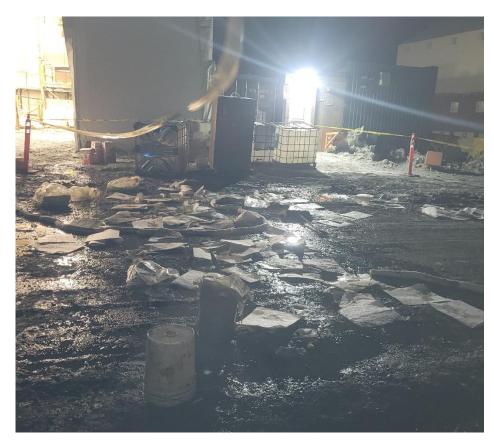
Spill Location: N65°24'21.8 W96°40'48.9"

During night shift operations at the Whale Tail Mine, a tote containing 1000L of hydraulic oil was punctured by equipment during the process of moving the reservoir, causing about 500L of oil to leak onto the ground of the service building pad. The tote was flipped over to prevent additional oil from leaking out of the container.

Punctured tote caused by misalignment of the equipment forks.

The incident was reviewed with all operators within the department. A tote handling procedure has been implemented into site wide training for forked equipment. Additional lighting options are being investigated to improve lighting in the workplace for the night shift.

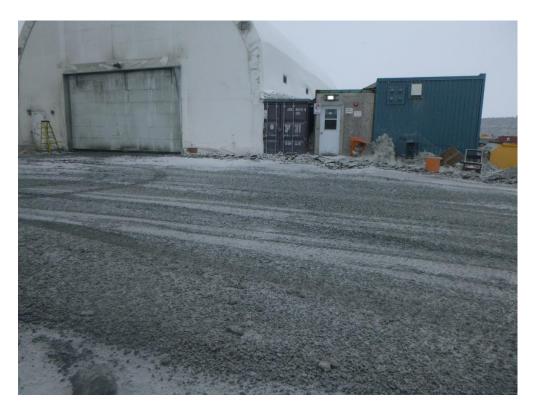
Absorbent booms were used to halt the spill from going further and spill response material was used to collect as much oil as possible. Approximately 15m³ of contaminated material was collected and disposed of at the Whale Tail Mine Landfarm.
