2023-06-12-WTM 2.8m3 Hydraulic Oil

GN reference #: 2023-253

Spill Description

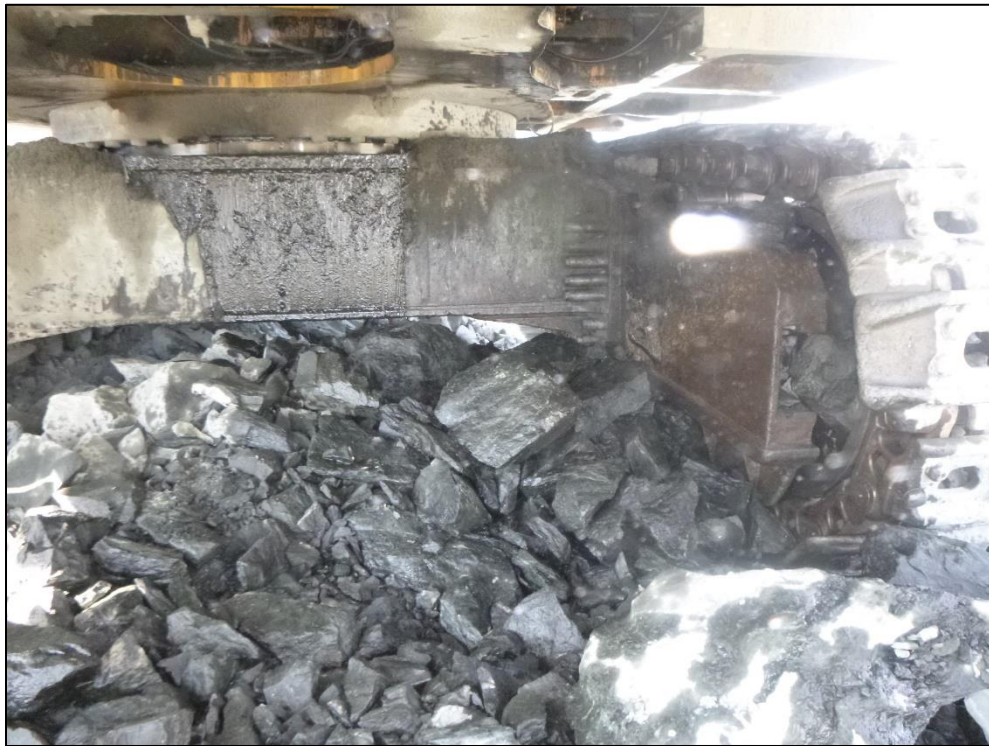
During operations at the Whale Tail Mine, the excavator was in the motion of turning around on a pad when a rock boulder made contact and damaged the hydraulic system of the equipment resulting in 2.8m3 of hydraulic oil to spill onto the ground of the Whale Tail Pit. The spill occurred in an active excavation area.

Hydraulic system was damaged by a large boulder.
