2023-06-15-WTM 250L Hydraulic Oil

GN reference #: 2023-257

Please find the following information as a follow up to the Spill report submitted June 16th, 2023, by Agnico Eagle Meadowbank division. This detailed report is submitted to the Inspector in compliance with the conditions under the Nunavut Water Board License 2AM-WTP1830, Part H, Item 8c.

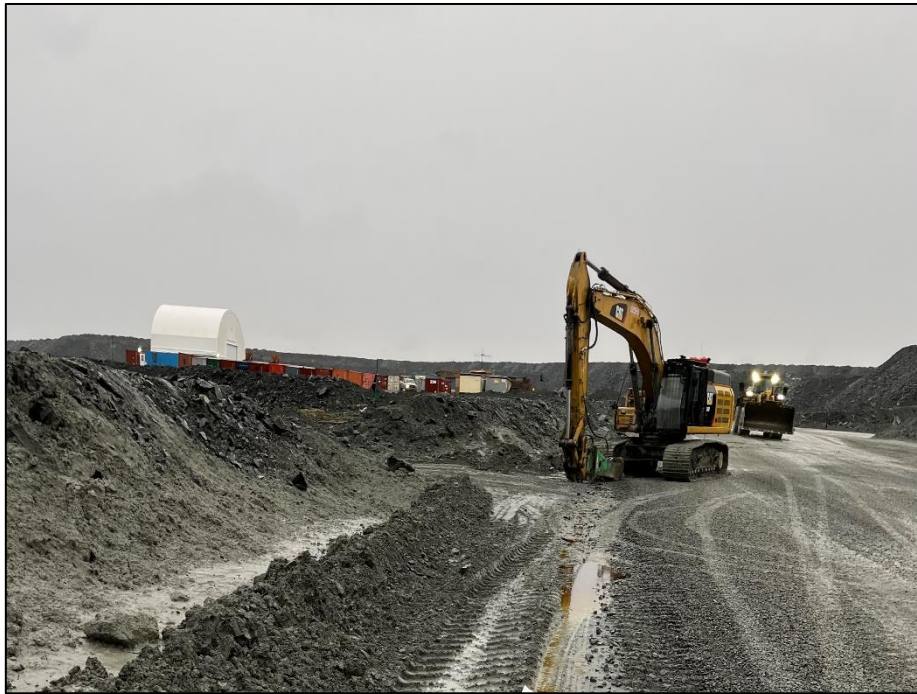
During operations at the Whale Tail Mine, the excavator was in the motion of walking to a pad when a hydraulic hose broke resulting in 250L of hydraulic oil to spill onto the ground of the Whale Tail Pit Road. There is no plan currently to excavate this area of the roadway.

Hydraulic line failure

A routine visual inspection of all systems is performed during pre-operation checks as a part of the preventative maintenance program. In addition, an environmental incident reduction plan has been developed. This plan includes a review of mechanical equipment failure, including hydraulic hose failure, to identify and address root causes.
